# Assessment and Rehabilitation of Damaged Buildings in Historic Benghazi City

The primary focus of the study is to assess and classify the damage in the old Benghazi City. Specifically, it aims to evaluate buildings within a designated area, which is bordered by Umar Ibn Al-Aas Street to the south, Omar Al-Mukhtar Street to the north, Ben Issa Street to the east, and the extension of Gamal Abdel Nasser Street to the west. The main objective is to gather valuable insights and data that can support effective rehabilitation or reconstruction efforts. By comprehending the extent of the damage and categorizing it accordingly, the study seeks to provide essential information for decision-making processes and determine the most appropriate approach for restoration. The ultimate aim is to ensure the safe return of residents to the affected area. In addition to this, the restoration process aims to preserve and revitalize the city's religious, historical, and distinctive features. This includes safeguarding religious structures, landmarks, and elements that contribute to the city's unique identity. To achieve this, the study proposes separate rehabilitation schemes tailored for ordinary b

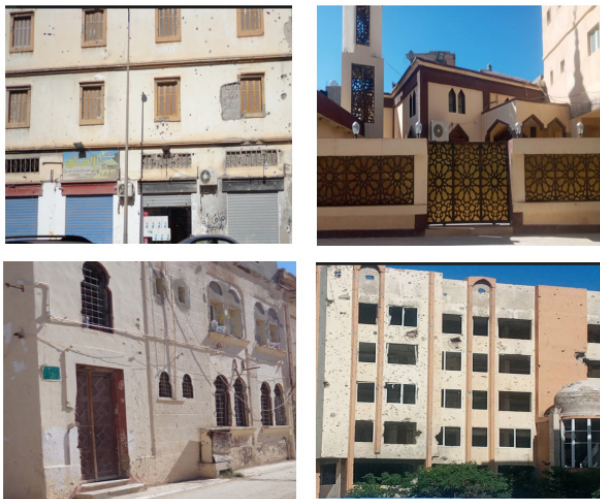
Among the buildings inspected, a subset of 168 structures (56% of the total) fall into this category. The observed damage in these buildings is non or limited to specific architectural elements while maintaining the integrity of their structural components. Examples of these buildings are shown in **Figure 2**.

**Figure 2.** Examples illustrating buildings without significant damage.

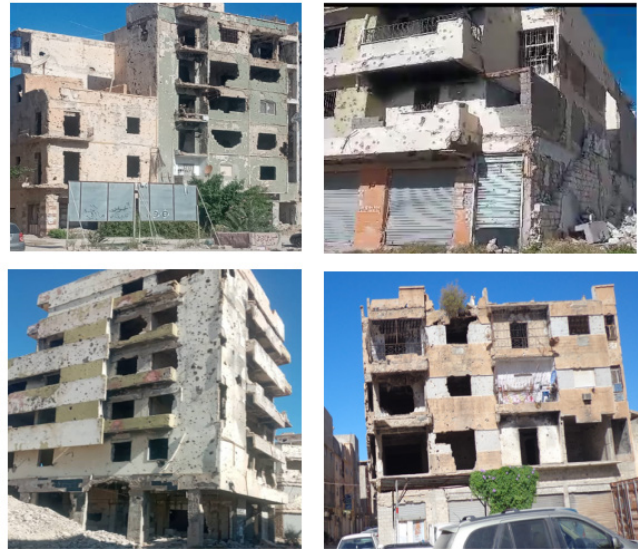
83 buildings, accounting for 27% of the total, have been identified as having medium damage. These buildings display a level of damage that is deemed feasible for rehabilitation to their structural integrity. This rehabilitation process will involve the implementation of appropriate repair techniques, the use of suitable materials, and the application of structural reinforcements where necessary. Illustrative examples are the buildings shown in **Figure 3**.

**Figure 3.** Examples illustrating buildings with medium damage.

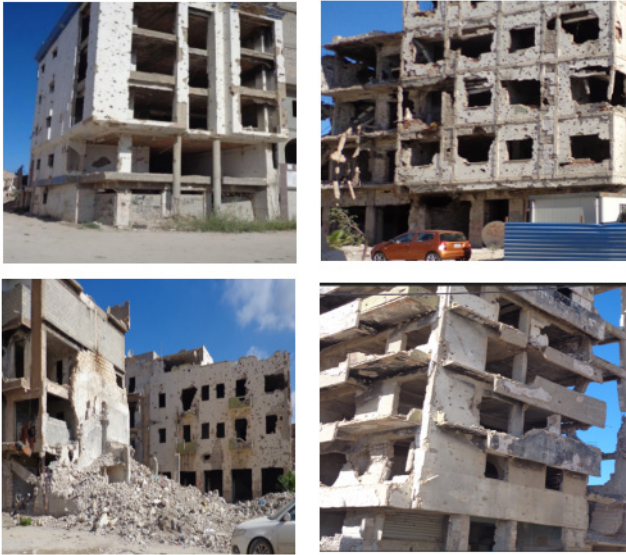
Within the examined structures, a subset of 13 buildings (4%) necessitates additional studies that involve testing the structural elements and conducting a comprehensive structural analysis. These investigations are crucial for making informed decisions regarding whether to rehabilitate or proceed with demolition and subsequent reconstruction. Illustrative examples are the buildings shown in **Figure 4**.

**Figure 4.** Examples illustrating buildings require further investigation.

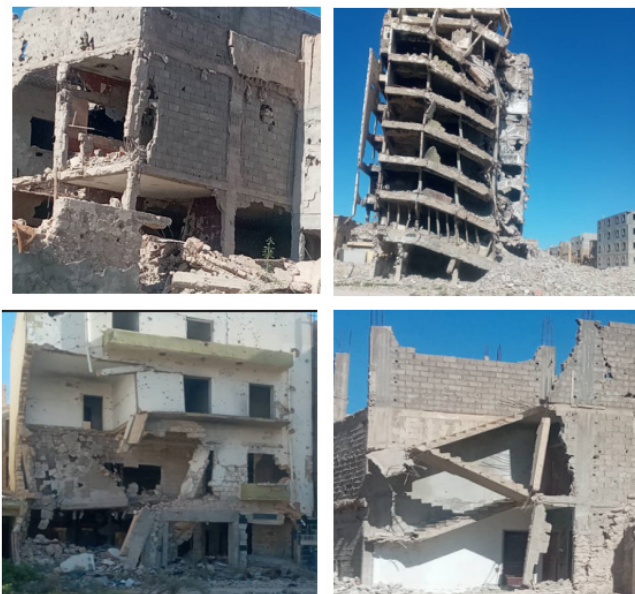
Out of the inspected buildings, a total of 36 structures (13%) were found to be either completely collapsed or severely damaged. These buildings are determined to be beyond repair and necessitate dem-

olition, followed by the reconstruction process. Illustrative examples are the buildings shown in **Figure 5**.

**Figure 5.** Examples illustrating buildings of completely demolished or severely damaged.

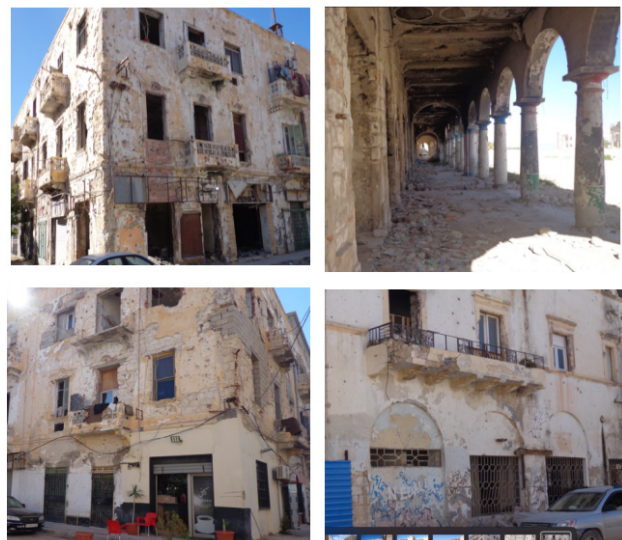
**Figure 6.** Examples illustrating old structure buildings.

area hold historical importance, primarily dating back to the Italian colonial era. These buildings, with their rich heritage and architectural fabric, are recommended for rehabilitation to ensure the preservation of their historical status. To maintain the cultural value of these historical buildings, it is advised to undertake their rehabilitation using the same architectural style and materials that were originally employed in their construction. This approach not only safeguards their historical integrity but also contributes to the preservation of the overall architectural fabric of the area. Illustrative examples are the buildings shown in **Figure 6**.
