# Sequential Damming Induced Winter Season Flash Flood in Uttarakhand Province of India

204 persons were killed while two hydropower projects located in close proximity at Rishiganga (13.2 MW), and Tapoban (520 MW) were damaged in Dhauliganga flood of February 7, 2021 in the Indian Himalaya. This incidence occurred during the winter season when the discharge of the glacier fed rivers is minimal, and no rain was experienced in the region around the time of the flood. Despite discharge of the main river, Rishiganga, not involved in the flood due to damming upstream of its confluence with Raunthi Gadhera, based on field evidences massive volume of around 6 million cu m water involved in this flood is attributed to sequential intermittent damming at three different places; (i) Raunthi Gadhera was dammed first in its upper reaches, (ii) Rishiganga river was then dammed to the north of Murunna, and (iii) finally Dhauliganga river was dammed around Rini village to the upstream of its confluence with Rishiganga river. Lacking warning system only enhanced the flood-induced devastation. Legally binding disaster risk assessment regime, together with robust warning generation, and disseminati

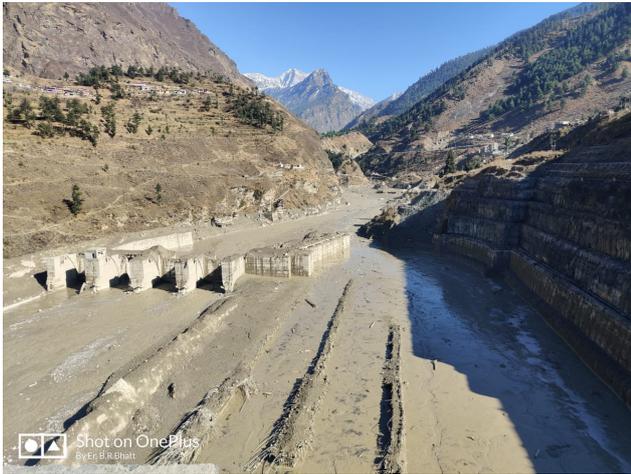
**Figure 2.** Devastation at the dam site of Dhauliganga hydropower project.

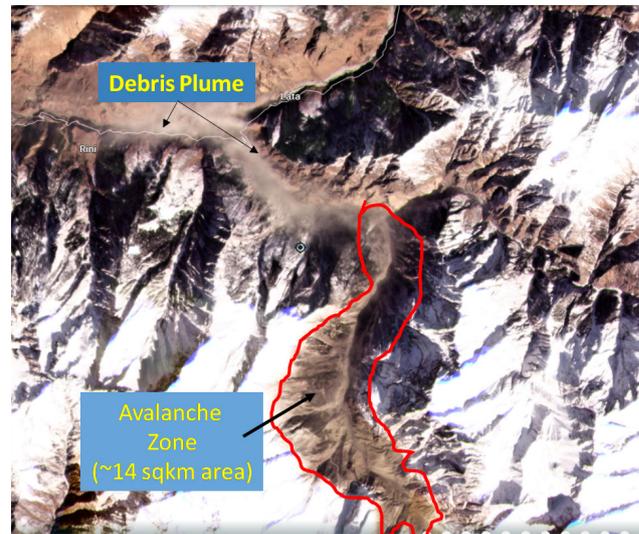
On February 10, 2021 Indian Institute of Remote Sensing (IIRS), Dehradun reported sudden disappearance of snow over almost 14 sq km area (Figures 3 and 4), and added that the avalanche triggering the event also involved melting of fresh snow over this area. Apart from the energy generated by the impact of the rock fall <sup>[15]</sup>, presence of water was attributed to abnormal rise in temperature that was ascertained from the WRF model. Volume of water generated in this process was estimated

**Figure 3.** Planet Lab satellite data of the area of February 7, 2021.

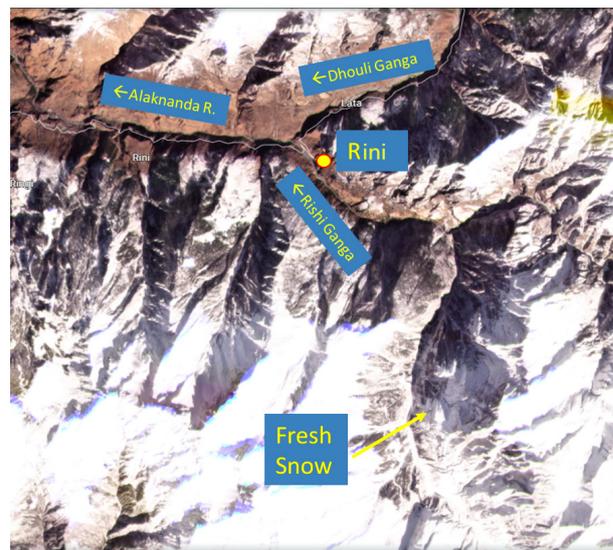
**Figure 4.** Planet Lab satellite data of the area of February 6, 2021.

however received some precipitation on February 4 and 5, 2021 and higher reaches experienced snowfall that is observed in the satellite imagery of the area (Figure 4).

Moreover, the region witnessed precipitation on February 4 and 5, 2021 and fresh snow was present in the upper reaches of the catchment on February 6, 2021 (Figure 4). Sharp rise in temperature on the very day of this incidence facilitated fast melting of freshly accumulated snow as also detached ice mass (Figure 3), and this water accumulated upstream of the avalanche debris. As put forth by an unpublished report of GAPHAZ, buried ice and water trapped under and within the 2016 avalanche debris would have also added to this water.

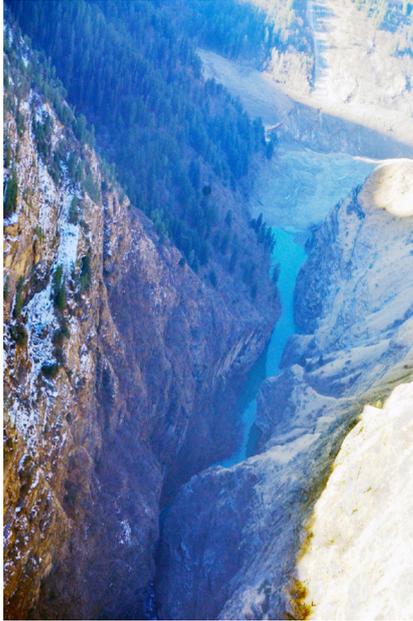
**Figure 5.** View of the lake formed in Rishiganga river on February 11, 2021.

flood. Moreover, Rishiganga river, with a catchment area of 664 sq km, being the main tributary of Dhauliganga river, was blocked by the debris brought down by the rock fall-avalanche along the Raunthi Gadhera (Figure 5). This implies that the flood resulting in additional discharge of 1,629 cumecs in the Alaknanda river was caused by the Raunthi Gadhera alone. It is not convincing if a small rivulet with catchment area of only 83 sq km could generate enough water to cause this massive flood.

The fast moving and debris, ice and rock mass laden flow of Raunthi Gadhera smashed against the valley wall on the right bank of Rishiganga river (2315 m asl). High angular relationship of these streams caused flow deflection, which facilitated backflow along Rishiganga river and large volume of rock and debris material was transported upstream along Rishiganga river for about 500 - 700 m and dumped there (Figure 5). This barrier cut off discharge of Rishiganga river and the water draining down from Raunthi Gadhera alone flowed downstream along the course of Rishiganga river till February 12, 2021.

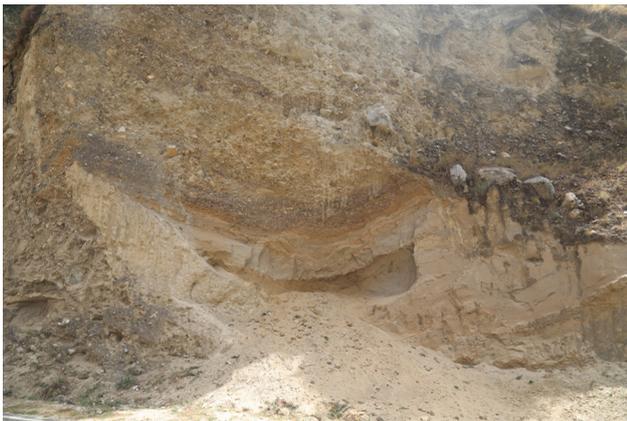
Evidences of previous damming are observed on the left bank of Dhauliganga river on road section close to hot spring at Tapoban. These lacustrine deposits consist of an inter-bedded sequence of sand, silt, and pebbles (Figure 6).

**Figure 6.** Evidence of ponding on the left bank of Dhauliganga river in the proximity of hot water spring near Tapoban.

Geomorphic conditions in the Dhauliganga valley provide suitable conditions for river blockade and the same is testified by field evidences of damming at two places (Figures 6 and 9). Field evidences further reveal that the flash flood event of February 7, 2021 was accompanied by damming at three different places, besides the one upstream of the confluence of Raunthi Gadhera and Rishiganga river. This facilitated accumulation of enough water, despite discharge of Rishiganga river being cut off, and explains devastating flood during the lean flow season.

It seems that the flood history of Dhauliganga river (Table 2) and evidences of previous damming (Figure 6, and 9) were ignored while planning the hydropower projects. Comprehensive inventory of previous disaster incidences is therefore recommended to establish the hazard profile of the area. Risk assessment should accordingly be undertaken and account for extreme events with long recurrence period. This should be a mandatory legal requirement for all major developmental projects in the Himalayan region. Putting these reports in public domain would either discourage the insurance companies

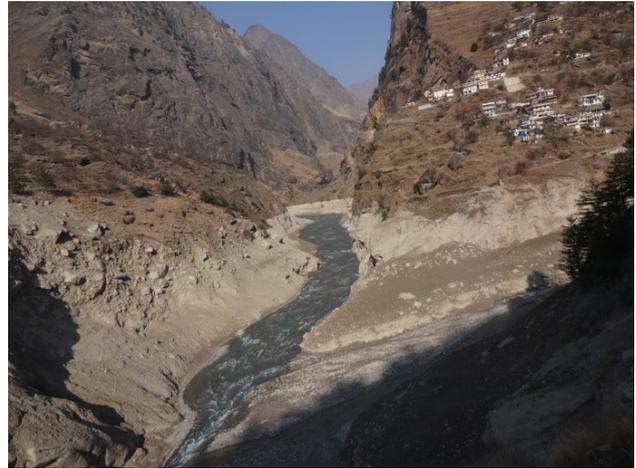
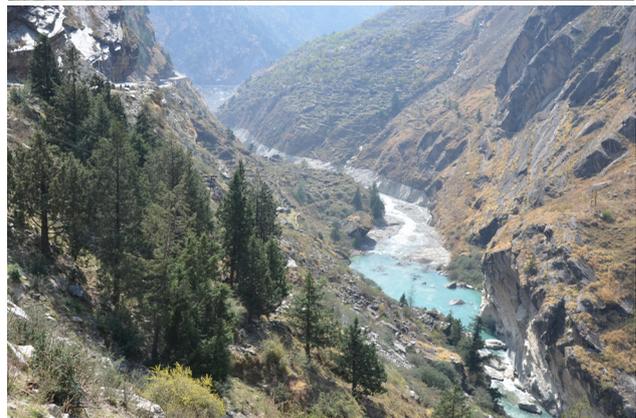
Distinct marks of inundation and fresh erosion are observed on both the valley walls of Dhauliganga river upstream of its confluence with Rishiganga river near Rini village at an altitude of 1,960 m asl, for about 1 km. From the impressions on the valley walls the level of the impounded water is assessed as being 3-4 m above the normal river level (Figure 7).

**Figure 7.** Erosion marks on the valley walls of Dhauliganga river near its confluence with Rishiganga river (above), and 1 km upstream along Dhauliganga river (below).

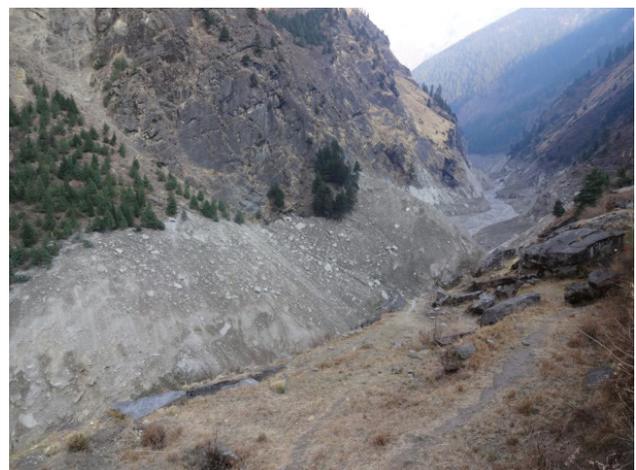
To the N of Murunna (Figure 1), Rishiganga river is observed to have constricted valley configuration. Fresh deposits of debris are observed at this site on both the banks. The inundation and erosion marks observed on the valley walls at this site suggest the floodwaters to have reached 40-50 m above the riverbed (Figure 8).

**Figure 8.** Erosion marks on the valley walls of Rishiganga river to the N of Murunna.

Though the discharge of Rishiganga river was blocked by the debris barrier, the floodwaters of Raunthi Gadhera travelled downstream along the course of Rishiganga river. Field evidences suggest that the course of Rishiganga river was blocked again intermittently to the N of Murunna (Figure 1) by the debris being carried by the floodwaters. Constricted valley configuration at this site facilitated the damming (Figure 8). Deposits of debris are observed at this site on both the banks and evidences on the valley walls suggest that the impoundment was up to 40-50 m above the riverbed.

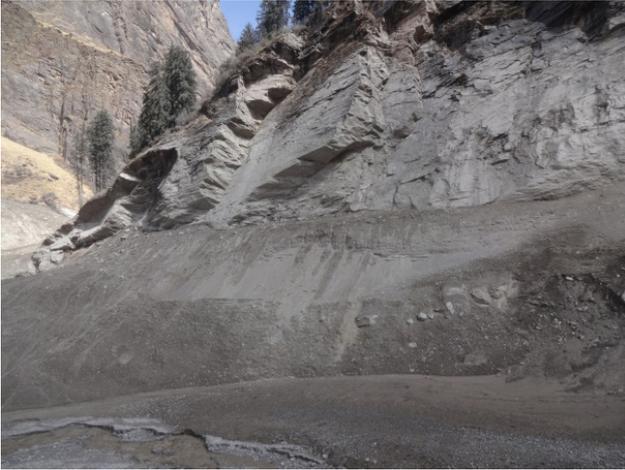
Evidences of previous damming are also observed on the right bank of Raunthi Gadhera upstream of its confluence with Rishiganga river. These lacustrine deposits are observed to consist of an inter-bedded sequence of sand, and pebbles (Figure 9).

**Figure 9.** Evidence of ponding on the right bank of Raunthi Gadhera near its confluence with Rishiganga river.
