ARTICLE

# Geotechnical Risk Assessment and Geological Origin of Building Fracturation in Agadez City (North Niger)

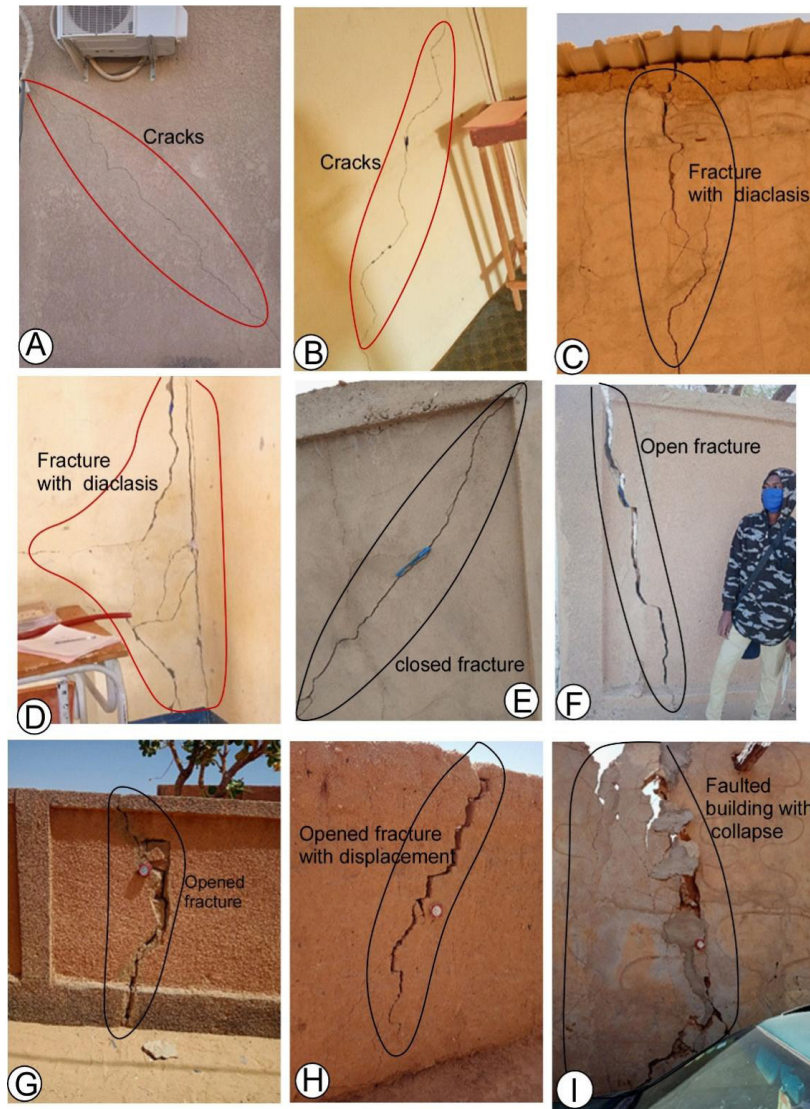
- cracks (fine close fractures having a millimetric width Figure 4A) which are considered to be a low-risk structure;
- fractures in the strict sense (the opening of the lips has a millimetric to centimetric width, Figure 4B): these types of structures present a lower risk of building collapse;
- faults planes (these are fractures along which collapse can be observed in buildings, Figure 4C). They present a high geotechnical risk, usually leading to the abandonment or reconstruction of the building.

**Figure 4.** In situ photographs of deformation structures showing the impact of hazards on homes. (A and B) cracked buildings (low risk), (C, D, E, F) fractured buildings (medium risk of collapse), (G, H, I) fractured and faulted buildings (high risk of collapse).

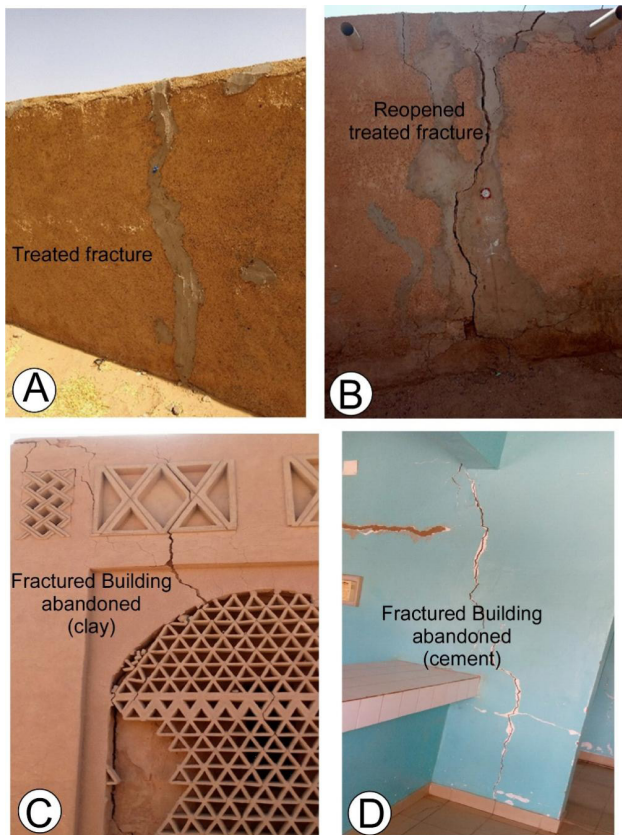
This is the case of the buildings of the Regional Direction of Hydraulic (HRD, Agadez, Figure 7C) and some blocks of the Regional Centre of Mother and Child (CRME, Agadez, Figure 7D).

**Figure 7.** Mitigation and riposte measures against the risk of fracturation of houses in the city of Agadez. (A) Treated fracture, (B) reopened treated fracture (with post-compaction operation), (C) abandoned block in clay material (Dagmanet Town hall, Agadez), (D) abandoned block in final material (Maternity, Agadez).

Despite the damages caused by this geotechnical risk of fracturation, preventive and riposte measures remain still classic. These measures involve the filling of open fractures with cement, which are not yet collapsed (Figures 7A-7B). In some cases, processed fractures continue to widen despite clogging, leading to the definitive abandonment or reconstruction of the building.

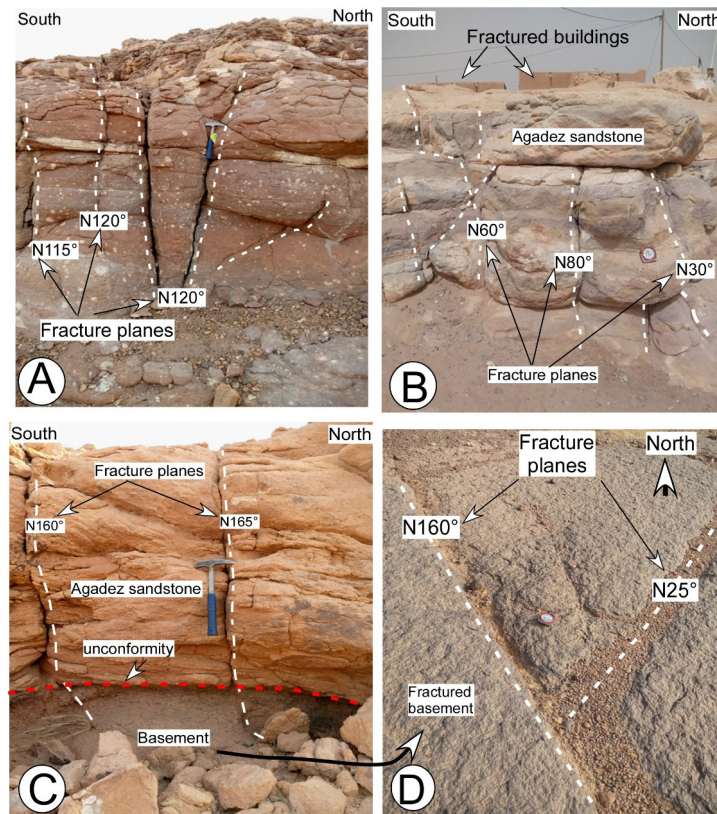
A structural study carried out on the Agadez sandstones and the underlying basement (Figure 9), showed that faults and fractures oriented  $N120^\circ$  to  $N165^\circ$ , affect both the basement of the Air Mountains and the sandstone formations on which the city of Agadez is built (Figure 9D). These observations indicate a close relationship between the seismic events affecting the Air Mountains and the cracking of buildings in the Agadez city.

**Figure 9.** In situ photographs showing the narrow-relations between building fracturation and those affecting the underlying sandstones and basement. (A) Tchibbinnitan fractured sandstones, (B) buildings and their underlying fractured sandstones, (C and D) respectively Agadez sandstones and its underlying basement, all affected by the same directions of fractures.
