ARTICLE

Analysis and Discussion on Subway Construction Accidents from Geological Perspective

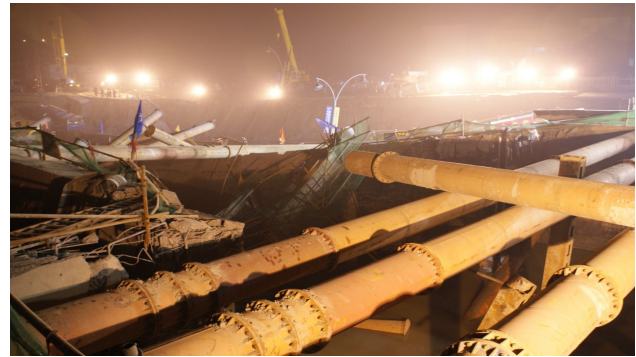
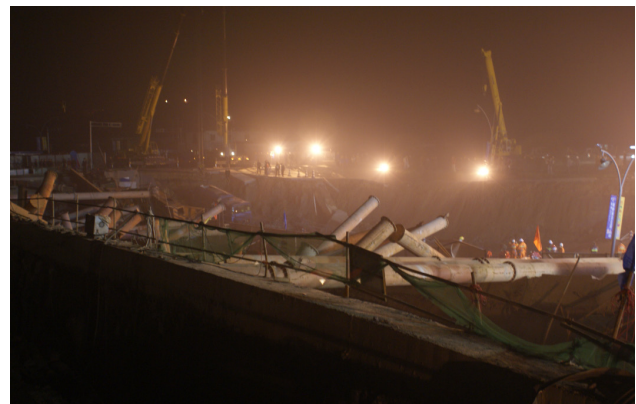
Figure 1. The construction accident at Xianghu Station of Hangzhou Metro Line 1, China.

Accident 6: On November 15, 2008, a large-scale collapse occurred at the construction site of Hangzhou Metro Line 1, which caused the 75-meter pavement of Fengqing Avenue to collapse with a subsidence of 15 meters. 11 driving cars fell into the pit. The collapse of the soil outside caused the wall of foundation pit to be unstable. Then the supporting system collapsed, and a large amount of mud water flooded into the foundation pit. Four crumbling dilapidated buildings were forced to be demolished around the construction site. The residents within 500m were evacuated and transferred. 35 subway stations under construction in the city had to be suspended. This accident resulted in 21 deaths and 24 injuries, which is one of the most serious accidents in the history of metro construction in China. In this paper, the author will focus on the accident as the engineering background to analyze the cause of the accident and the measures taken, as shown in Figure 1.

In Accident 6, the geology of the site is complicated, and it's rich in groundwater. Most of the soil layers are soft clay. The engineering work such as subway foundation pit excavation and shield tunneling is like drilling a hole in the cake, which is quite risky. The specificity of the soil mechanics parameters of groundwater and soft clay should be fully considered in the design. For the stability analysis of foundation pit, it is inappropriate to use consolidated undrained strength index and saturated unit weight for saturated clay. The design team has not paid enough attention to the particularity of soft clay.

When it comes to piles, walls and inner strut in deep soft soil areas, stability in depth must be considered, including pile and wall settlement, upheave and "skirting" damage, which should be strictly calculated by various methods. If it cannot meet the requirements, it should deepen the depth of pile and wall into soil or reinforce the passive area. In Accident 6, the project design has not paid enough attention to this, and no passive zone reinforcement has been carried out.

The quality of a project ultimately depends on the quality control of construction. One of the most important reasons in accident 6 is that the steel support booster was not added enough, which made the bearing capacity of the protective wall insufficient. Generally speaking, the booster should be added to more than 200 tons, even 300 tons in geological conditions such as Hangzhou, but in terms of the accident site, it is certainly not enough.

In addition, the protective wall of the west subway section underwent tremendous deformation. The sliding of the protective wall had occurred sometime before the accident. Earlier, many on-site construction workers had also noticed cracks on the wall, but no measures were taken. Besides, serious road subsidence and multiple cracks occurred one month ago, which actually reflected the change of soil mass, but it was still ignored as a result of excessive traffic flow by the construction team. Moreover, in the construction process, the foundation pit was seriously over-excavated. The supporting system had serious defects. The steel pipe support was not timely erected, and the cushion was not timely poured, either.

However, after the accident, it was found that the interval between sections was 60 meters. Although it is difficult to establish a direct causal relationship between the shortening of construction period and cave-in accidents, facts show that the shortening of construction period indirectly promotes the occurrence of accidents to a certain extent, so that dangers which could have been discovered are ignored intentionally or unintentionally.

In Accident 6, the soil near the station was relatively soft with high fluidity. The pressure caused by the traffic flow on the west Fengqing Avenue led to the soil layer below moving toward the subway construction site. In addition, the previous rainfall caused the surge of river in the east. The softer soil also increased the mobility of the soil layer. Under this background, monitoring data such as horizontal displacement, earth pressure and water level change should be able to detect the abnormal situation in advance and send out an alarm so that the construction team could take corresponding measures. But in that situation, this was obviously not well tackled.

(2) In the engineering design, it's inappropriate to use consolidated undrained strength index and saturated unit weight to calculate the strength of groundwater subsoil, to analyze the stability and to check the bottom upheave. The highly sensitive soft soil was not given enough attention and no effective measures were taken. A mistake was

made at the time when Fengqing Avenue was not closed. The checking calculation of pit overload based on consolidated undrained strength was also dangerous. In addition, according to the disturbance degree of the subsoil, the disturbed soil is strengthened by layers.

(3) In the construction process, it is necessary to ensure the construction quality of the underground continuous wall, and dewatering should be carried out according to the design.

(4) Strengthen monitoring and measurement. During the excavation of the foundation pit, it is necessary to ensure the safety of the pit, the surrounding buildings and underground pipelines. Therefore, in the construction process, informationized monitoring of foundation pit and its surroundings should be strengthened, and the monitoring data should be promptly sent to the construction team.

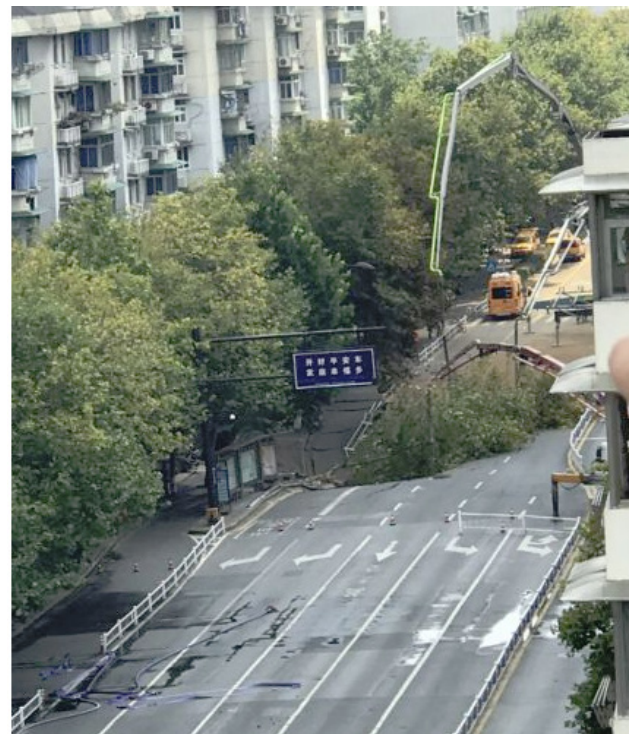
Figure 2. The construction accident of Hangzhou Metro Line 5, China

Accident 8: At 11 am, August 28, 2019, a road surface collapse occurred at the intersection of Jianguo North Road and Stadium Road in Hangzhou (Figure 2).

Through the analysis of the accidents above, it is found that there are often water pipes or ground seepage around the foundation pit. For example, at the beginning of Accident 1, a small seepage appeared in the subway foundation pit, followed by a large-scale piping, and water with yellow sediment flooded into the subway foundation pit of Shanghai Metro Line 9. Meanwhile, the ground near the foundation pit began to fall, and the road about 50 meters long also collapsed in a large scale. This reason also applies in Accident 4 and Accident 6. According to the survey, the foundation soil near the Qiantang River is silty clay, and the groundwater level is high. In addition, the site is located in the main road, where traffic flow is relatively large. There are many large buses and trucks running on this road, which has brought impact on the western load-bearing wall of the foundation pit. In October 2007, a rare continuous rainfall occurred, which further increased the fluidity of soil under the foundation. Accident 8 was caused by water seepage in the construction of connecting passage of Hangzhou Metro Line 5, which resulted in pavement collapse and gas leakage.
