ARTICLE

Assessment of Subsurface Competency Using Geotechnical Method of a Proposed Structure F.C.T Nigeria

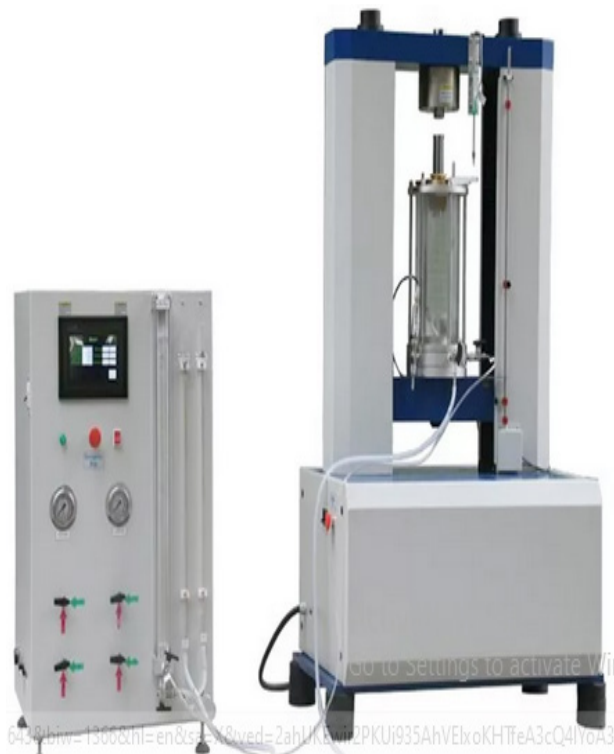
Figure 3. Triaxial compression test equipment.

These mainly require figuring out the strength characteristics that can be used to compute the bearing pressure of the soil. Unaltered samples were subjected to a triaxial compression test, whereas disturbed samples were subjected to a shear box test. These are the tests included in this category: (i) Triaxial Compression Test. (Figure 3) (ii) Shear Box Test (Figure 4).

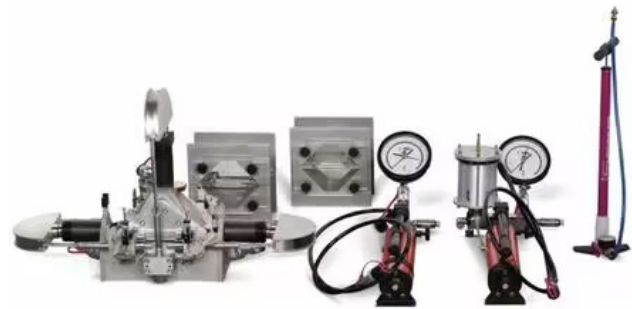
Figure 4. Shear box test equipment.
