ARTICLE

Study on the Tensile and the Fatigue Behavior of Air Plasma Sprayed YSZ TBC Systems

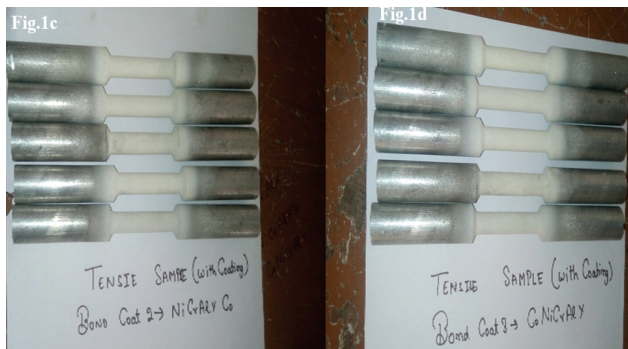
Figure 1 c. NiCoCrAlY bond coated TBC sample.

Figure 1 d. CoNiCrAlY bond coated TBC sample.

The cast Al-based aluminium alloy was selected as a base metallic alloy, i.e. substrate. The chemical composition (in wt.%) of used base metallic alloy is refer in Table 1^[3,5,6]. The feedstock material was agglomerated 8YSZ designated as M6700 (Oerlikon Metco). Testing sample, used for tensile testing and fatigue testing, made of aluminium alloy, with a diameter of 15 mm, were used as substrates and the top side edge of the specimens was rounded. Shape of both test tensile and fatigue were in cylindrical shape. Before the application of TBC, the substrates were coated with a 150 µm thick of bond coating materials, NiCoCrAlY & CoNiCrAlY (Amdry 386, Oerlikon Metco) by using the APS. The applied APS parameters for both the bond coat and top coat used are, as shown in Table 2 [3,5,6] and Table 3^[5,6]. Bare substrate used for both fatigue and tensile testing, before the application of bond coat and top coat, are shown in Fig.1(a&b) whereas Fig.1(c&d) presents the application of TBC on two different bond coats.

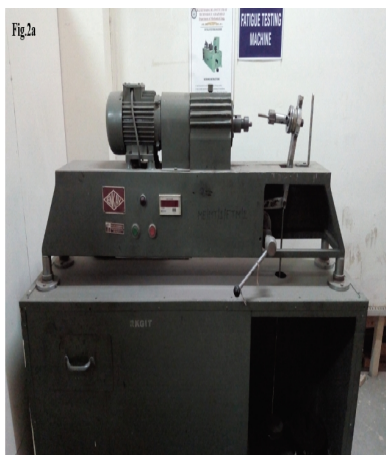
Figure 2a. Fatigue testing machine

Here, two type of testing, fatigue tests, and tensile tests of specimens, were performed on fatigue testing machine, see in Fig.2a., and universal tensile testing (UTM) machine, see in Fig.2b., respectively. Cross sectional optical micrograph of TBC is shown in Fig. 3.

In fatigue test, the testing samples in cylindrical shape, were subjected to mechanical loading imposed by a putting a 150N load on load span using a lever mechanism. For finding the mean values and variations of the results, here, minimum three samples were taken.

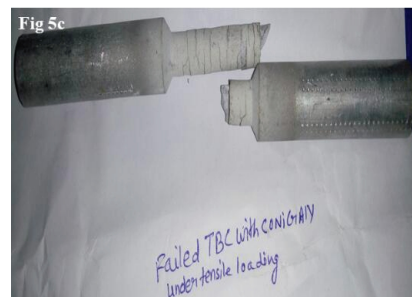
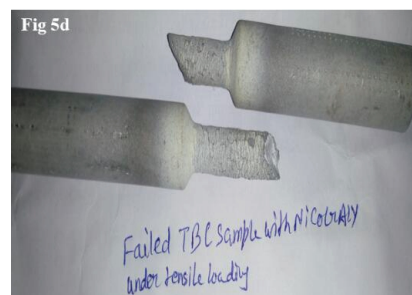
Figure 5. Failed TBC sample under tensile loading for: (c) NiCoCrAlY, (d) CoNiCrAlY Bond Coat.

All the fractured TBC specimens under tensile loadings as representative photos are shown in Fig. 5(a-d); however, the bond coating materials was different. Several vertical cracks to the direction of loading can be seen at the surface of the top coat and a small part of the top coat spalled in the fractured specimen of TBC as shown in Fig. 5(b-d). However, cracks can't be visible at the surface of the bond coat, see in Fig. 5(b). Similar observations were reported by various researchers; however, the metallic substrates were super-alloys [14,19-22].
