Hot Cracking Susceptibility of 800H and 825 Nickel-Base Superalloys during Welding via Spot Varestraint Test

Hot cracking susceptibility of fillers 52 and 82 in 800H and 825 nickel-base superalloys was discussed using the Spot Varestraint test. The fillers of 52 and 82 were added into nickel-base superalloys via a gas tungsten arc welding (GTAW). Experimental results showed that the hot cracking sensitivity of the nickel-base superalloys with filler at high temperature was lower than that without filler. The hot cracking sensitivity had a slight effect when the filler 82 was added. The total length of crack was increased, the liquid-solid (L-S) two-phase range is higher so that the hot cracking susceptibility will be raised. The morphologies of cracks included the intergranular crack in the molten pool, molten pool of solidification cracking, heat-affected zone of intergranular cracks, and transgranular crack in the heat-affected zone.

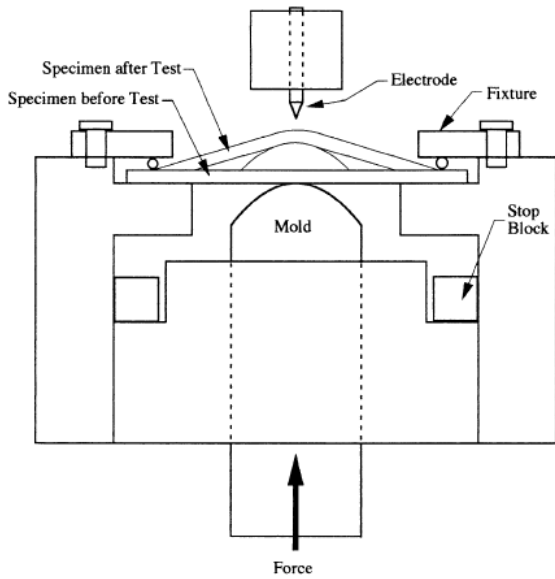
Figure 1. Spot Varcstraint test apparatus

The 800H and 825 nickel-base superalloys were welded using the gas tungsten arc welding (GTAW). The welding was performed with Nickel filler metals of 82 and 52 and welded on 800H and 825 Nickel alloys. The spot welding was carried out and hot cracking was estimated using the Spot Varestraint machine (see Figure 1). The welded samples were used to observe the microstructures, composition, macrostructures, average amount, average length, and maximum length.

The relationship between applied strain and crack length were discussed by Varestraint test and evaluate the hot cracking susceptibility^[9-11]. The crack in the HAZ and fusion zone (FZ) was estimated using the SOB (Spot on Bead) test^[12-16]. The Argon welding gun moved from left to center during test and the mold block of specific curvature radius is under the sample.

Both ends of the specimen were extruded via an oil pressure arm and then the center points of specimen were bent. Hence, the surface of specimen formed a strain (ε), as indicated as Equation 1:

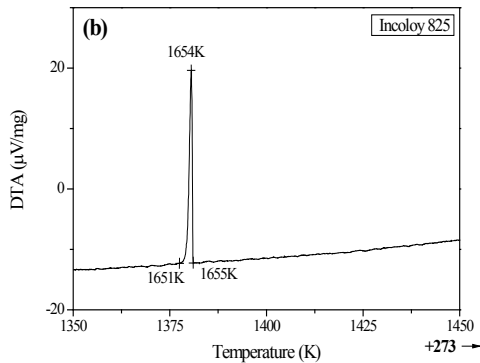
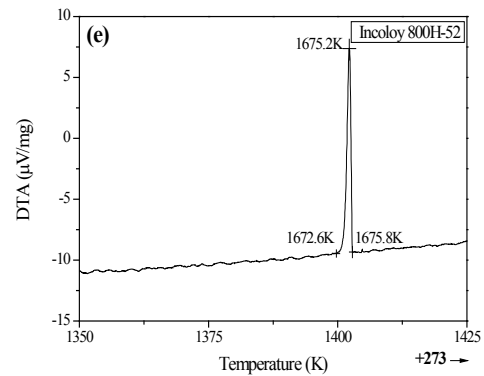
Figure 9. DTA thermal analysis of nickel-base superalloys

Note: (a) 800H (b) 825 (c) 52 filler (d) 82 filler (e) 800H-52 (f) 800H-82 (g) 825-52 (h) 825-82

Figure 9 showed the exothermic curves of the 800H, 825, 52 alloy filler, 82 alloy filler, 800H-52, 800H-82, 825-52, and 825-82. The liquidus temperatures (T_L) in 800H, 800H-52, 800H-82, 825, 825-52, 825-82, 52 filler, and 82 filler were 1709K(1436°C), 1676K(1403°C), 1651K(1378°C), 1654K(1381°C), 1671K(1398°C), 1637K(1364°C), 1669K(1396°C), and 1561K(1288°C), respectively. The temperature difference of residual liquid during the solidification can be represented as an index of the ΔT ($T_L - T_S$). The T_L and T_S are the liquidus temperature and solidus temperature. When the value of the ΔT is higher, residual liquid will be kept a long time at high temperature and then lose the strength of grain boundaries during coolingshrinkage. Consequently, the hot cracking will happen. No phase transformation was detected from the thermal analysis and then the single stabilize γ -phase was found in the nickel alloys from the XRD analysis. Table 4 showed the thermal analysis results of the nickel alloys. These ΔT values can be used to predict the hot cracking susceptibility in the nickel alloys. The order of hot cracking susceptibility of the nickel alloys was (a): 800H>800H-52>800H-82; (b): 825-52>825-82>825.

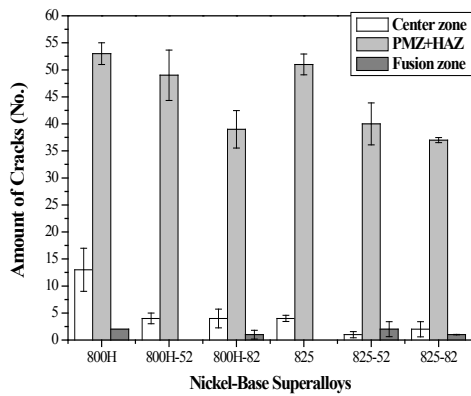
Figure 13. Amount of cracks in nickel-base superalloys

The average amounts of cracks were shown in Figure 13. The amount measurement of crack can divide into three regions of the center zone, FZ, HAZ plus PMZ (HAZ+PMZ). The crack length of the center zone in 800H alloy was the longest and obvious. However, the crack length of the crack of the center zone in 825-82 alloy was the shortest and unobvious. The order of crack amount in the center zone was 800H>800H-52>800H-82 and 825>825-82>825-52. However, that in the FZ was 800H>800H-52>800H-82 and 825>825-82>825-52. Furthermore, that in the HAZ+PMZ was 800H>800H-52>800H-82 and 825>825-52>825-82. From the amount of cracks and thermal analyses, the results of the crack amount and the ΔT value in the HAZ+PMZ indicated the same tendency. When the ΔT value increases, the amount of cracks will be increased.

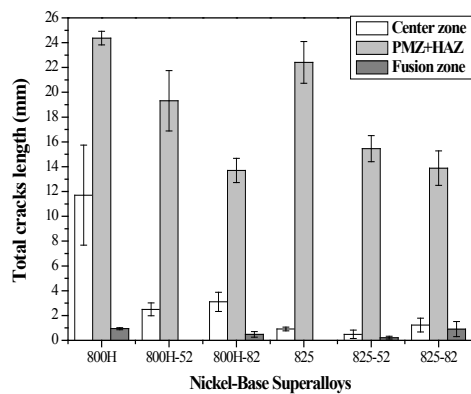
Figure 14. Total cracks length in nickel-base superalloys

Figure 14 showed the total length of the cracks in the nickel alloys of the center zone, PMZ+HAZ, and FZ. The total crack length (TCL) can be used to examine the hot cracking susceptibility. Generally, the amounts of the cracks were higher; the total length of the cracks was longer. The order of total length of the cracks in the center zone was 800H>800H-82>800H-52 and 825-82>825>825-52. On the other hand, that in the FZ was 800H>800H-

82>800H-52 and 825-82>825-52>825. Besides, that in the HAZ+PMZ was 800H>800H-52>800H-82 and 825>825-52>825-82. The total length of the crack in 800H alloy was the longest of the all nickel alloys so that the ΔT value was highest in 800H alloy. Consequently, the hot cracking susceptibility in 800H was more evident.

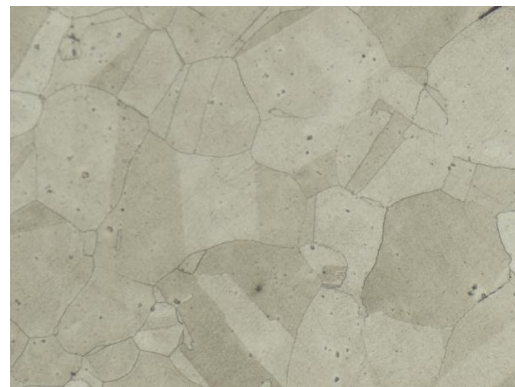
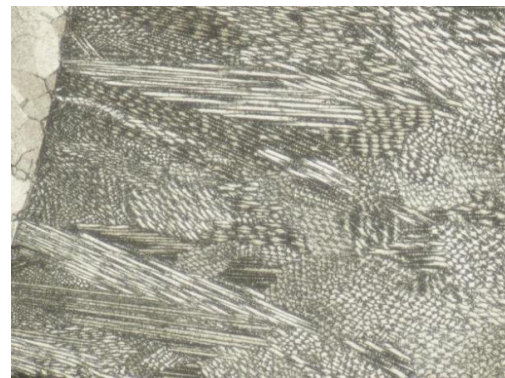
Figure 16. Microstructures of Spot Vareststraint test in different regions

Figures 16-17 showed the microstructural distribution of the Varcstraint test. Figures 16(a) and 17(a) were microstructures of the HAZ and had some annealing twins and smaller black points of the TiN precipitates in the grained structures. However, the microstructures indicated a planar growth if the filler was added into the matrix. Figures 16(b) and 17(b) were microstructures of the partial melted zone (PMZ) and the microstructures were similar to the FZ. This region was a like-planar growth and every planewas different direction growths. Figures 16(c) and 17(c) showed the microstructures of the FZ and this region exhibited a dendritic growth. It closed to the center area and had an obvious temperature gradient so that the dendritic growth was observed. Figures 16(d) and 17(d) were microstructures of the center zone and the microstructures were the equiaxed structures under high temperature difference.

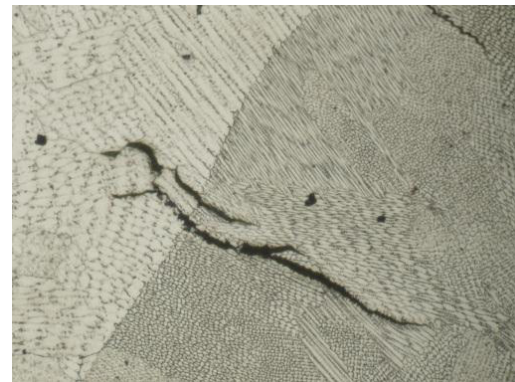
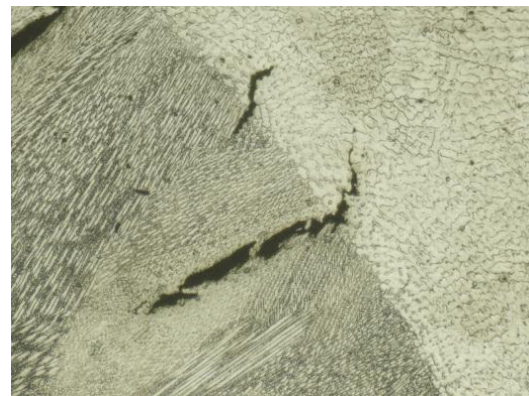
Figure 18. Metallographic micrographs of cracks in nickel-base superalloys

Note: (a) 800H, (b) 825, (c) 800H-52, (d) 825-52, (e) 800H-82, (f) 825-82

Figure 18 showed the metallographic observation of the crack in the nickel alloys and Figure 19 indicated the schematic diagram of different crack modes. Figure 19(a) was a crack in the FZ and high temperature difference led to the dendritic growth. The residual liquid does not backfill the crack completely so that the crack expanded along the two sides of dendrites. The residual liquid will be concentrate on the dendrites. Hence, the cracks were formed in above region under a critical deformation of the Vareststraint test. Figure 19(b) showed the transgranular crack in the HAZ. The matrix without filler addition was located in this region. It does not form a weak region for residual liquid in the dendrites and grains so that the transgranular crack can be occurred directly. Figure 19(c) was a crack with filler addition and the cracks were expanded in this area along the dendritic boundaries. The boundaries of different directions were weak so that the dendritic boundaries were beneficial region to form the cracks. Figure 19(d) exhibited the cracks for a planar growth in the partial FZ. The orientation in the partial zones was very random and the strength in the grains was low so that the cracks were formed easily along the grain boundaries.
