# Assessment and Rehabilitation of Damaged Buildings in Historic Benghazi City

The primary focus of the study is to assess and classify the damage in the old Benghazi City. Specifically, it aims to evaluate buildings within a designated area, which is bordered by Umar Ibn Al-Aas Street to the south, Omar Al-Mukhtar Street to the north, Ben Issa Street to the east, and the extension of Gamal Abdel Nasser Street to the west. The main objective is to gather valuable insights and data that can support effective rehabilitation or reconstruction efforts. By comprehending the extent of the damage and categorizing it accordingly, the study seeks to provide essential information for decision-making processes and determine the most appropriate approach for restoration. The ultimate aim is to ensure the safe return of residents to the affected area. In addition to this, the restoration process aims to preserve and revitalize the city's religious, historical, and distinctive features. This includes safeguarding religious structures, landmarks, and elements that contribute to the city's unique identity. To achieve this, the study proposes separate rehabilitation schemes tailored for ordinary b

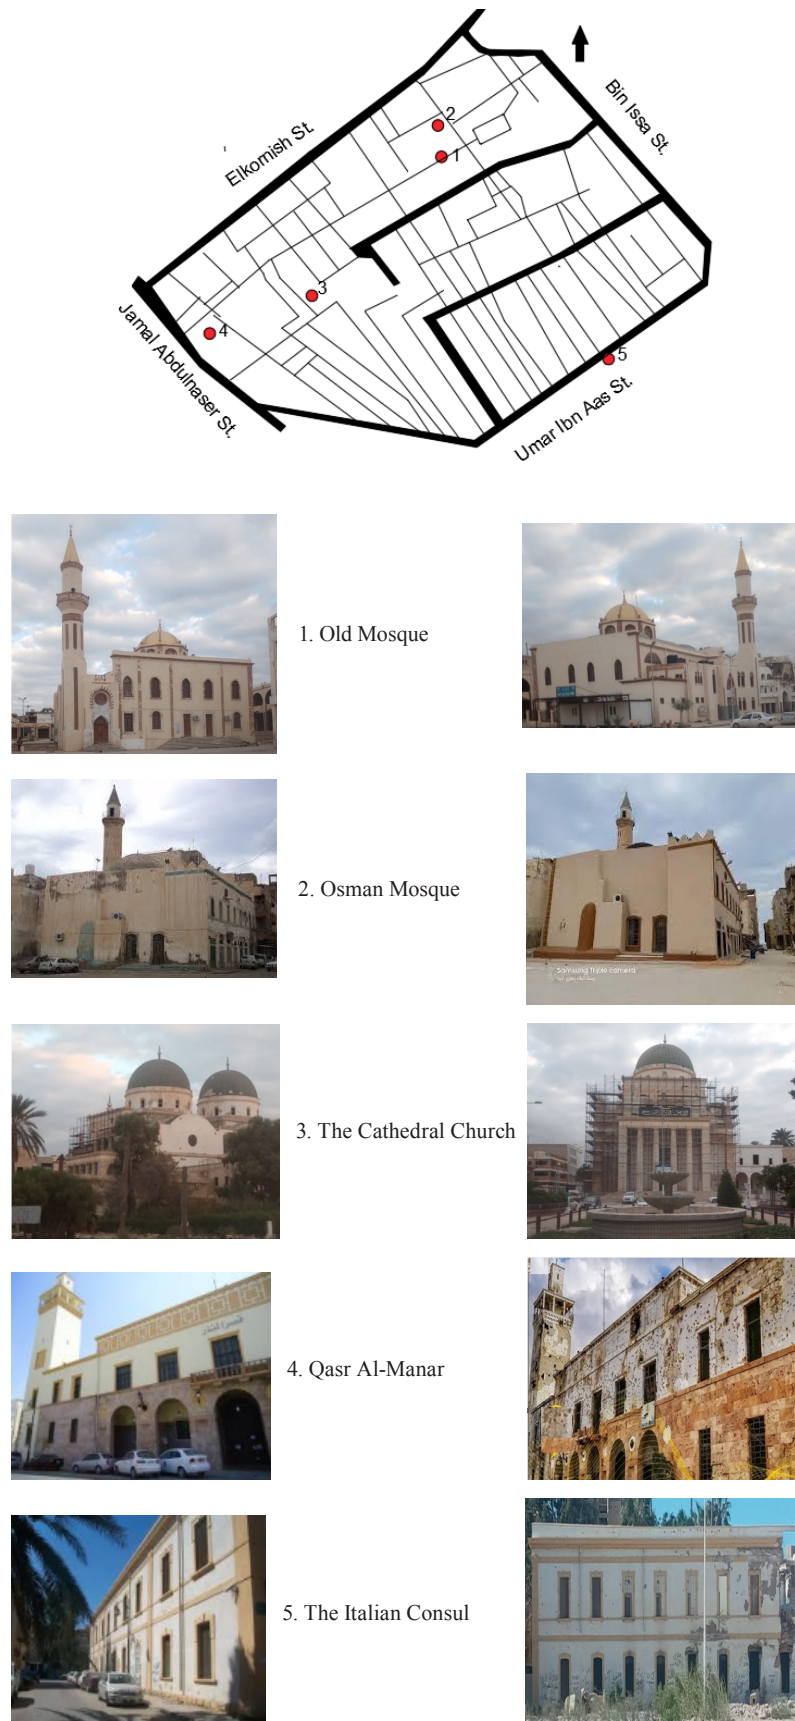
**Figure 8.** Photos of prominent historical buildings.

These buildings hold significant historical value within the study area, they are located as shown in **Figure 7**. Photos of the buildings are shown in **Figure 8**. Each building represents a distinct aspect of the region's heritage and cultural identity. Preserving these special buildings is crucial to maintaining the historical fabric and upholding the architectural legacy of the area. These buildings are:

- 1) Old Mosque
- 2) Osman Mosque
- 3) The Cathedral Church
- 4) Qasr Al-Manar (University of Libya)
- 5) The Italian Consulate

area hold historical importance, primarily dating back to the Italian colonial era. These buildings, with their rich heritage and architectural fabric, are recommended for rehabilitation to ensure the preservation of their historical status. To maintain the cultural value of these historical buildings, it is advised to undertake their rehabilitation using the same architectural style and materials that were originally employed in their construction. This approach not only safeguards their historical integrity but also contributes to the preservation of the overall architectural fabric of the area. Illustrative examples are the buildings shown in **Figure 6**.
