ARTICLE

# Geotechnical Risk Assessment and Geological Origin of Building Fracturation in Agadez City (North Niger)

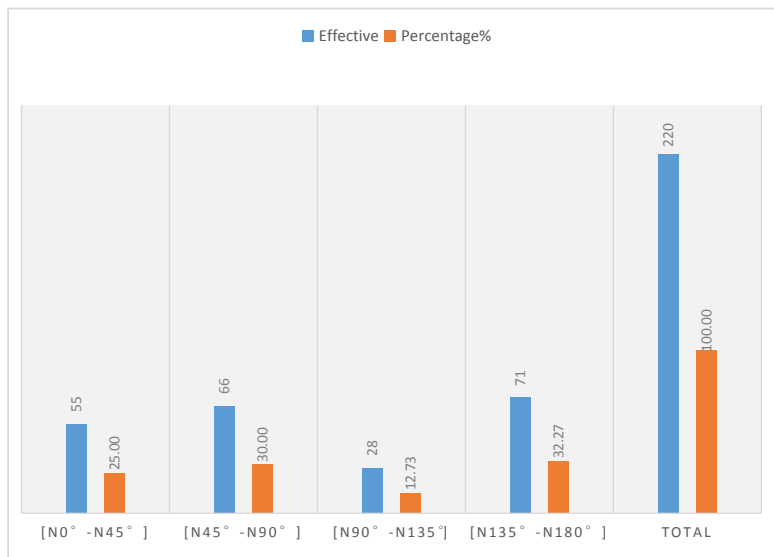
To determine the major direction of risk propagation, 220 measured planes of fractures are classified by direction interval of 45° from the North (Table 2 and Figure 5). The results of statistical analysis by the percentage of directions are as follows:

According to these observations, the directions ranging from SE-NW (N135°) to SSE-NNW (N175°) are the majority with 32%, followed by NE-SW (N45°) to E-W (N90°) directions with 30%. Therefore, the geotechnical risk related to the buildings fracturation has a stronger propagation component according to the mean direction NW-SE (N135°).

**Figure 5.** Histogram of 220 measured fractures planes according their directions.

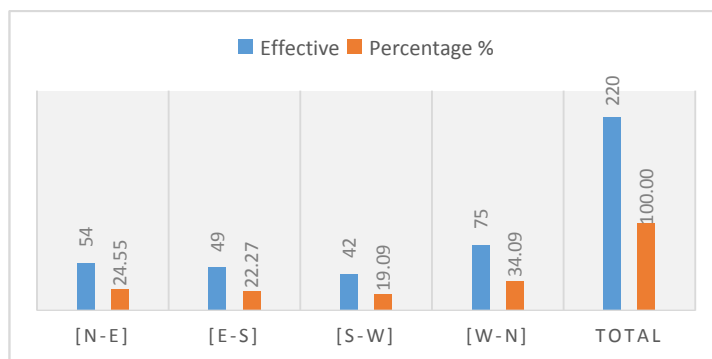
- 24.55% are dipped toward the Northeast sector,
- 22.27% toward the Southeast,
- 19.09% toward the Southwest, and
- 34.09% toward the Northwest (Table 3 and Figure 6).

**Figure 6.** Histogram of 220 measured fracture planes according to the dipping sectors.

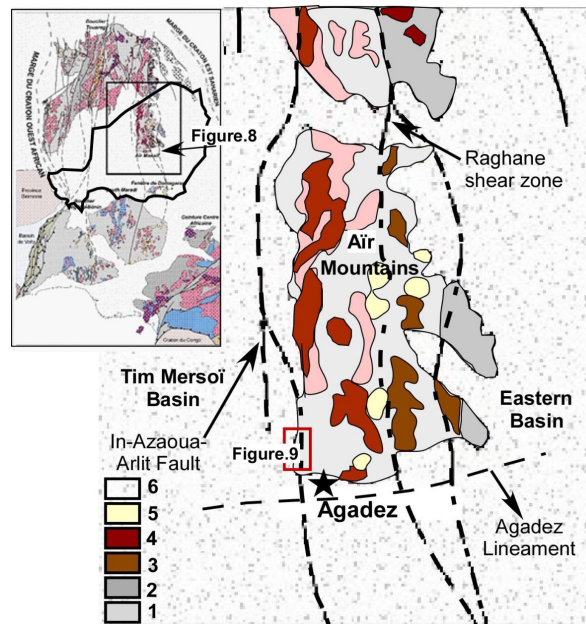
According to the geophysics interpretation map <sup>[15]</sup>, the N-S faults affecting the Agadez region (Figure 8) were the focus of three seismic events. The satellite fault of the In Azaoua-Arlit lineament, located to the west of the Agadez city (Figure 8), has been the focus of two seismic events (on May 19, 1967 and on January 18, 2017) according to the African seismic map <sup>[7]</sup>. In seismology, these three seismic events are considered to be a recurrence phenomenon (in this case every 50 years). Unfortunately, the data did not allow us to know the activity of this fault during the period 1907. If this recurrence is correct, another seismic event should affect this fault in 2067. The Raghane shear system, passing to the eastern part of Agadez city (Figure 8), was the focus of a seismic event on 4th July 1969 from geophysics interpretation map <sup>[15]</sup>. There is also a potential seismic zone corresponding to a system of strike slip faults oriented  $\sim N75^\circ$  (Figures 1 and 8), called "Agadez Lineament" <sup>[16]</sup> or the Guinean-Nubian Lineament (GNL) <sup>[17,18]</sup> that passed through the southern part of Agadez city <sup>[19,20]</sup>.

**Figure 8.** Trans-Saharan regional structures through Air Mountains: Raghane shear zone passing to Eastern part of Agadez city and In-Azaoua-Arlit Fault to Western Air Mountains <sup>[15]</sup>, modified.

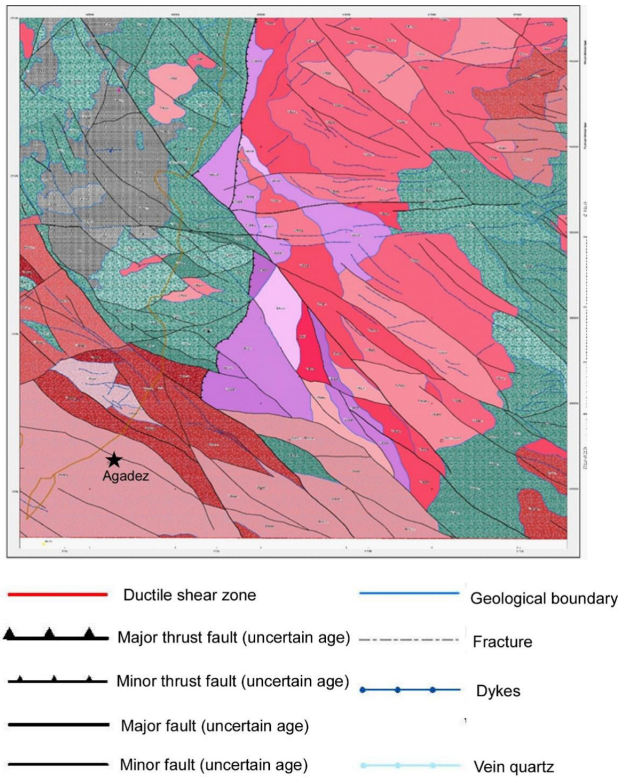
These faults and fractures oriented  $N120^\circ$  to  $N165^\circ$  have been identified on the pseudo-geological map of the southern edge of the Air Mountains, produced from the interpretation of Mag/Spectro and Mag/EM airborne geophysical data <sup>[15]</sup> (Figure 10).

**Figure 10.** Interpretation of the geophysical map from Mag/Spectro and Mag/EM <sup>[15]</sup>, showing the major directions of fractures affecting the crystalline basement of the Aïr, the Tim Mersoï basin sandstones and the Agadez city buildings.
