# Geo-textile in Riverbank-Embankment Protection from Flood Flow Erosion

### ABSTRACT

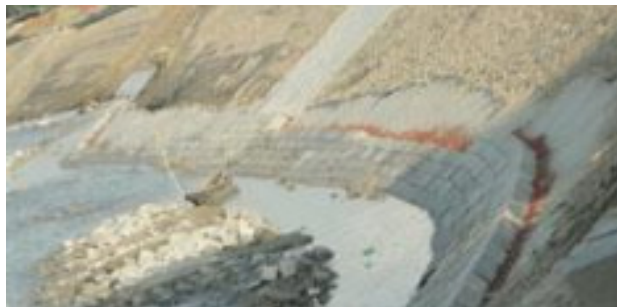
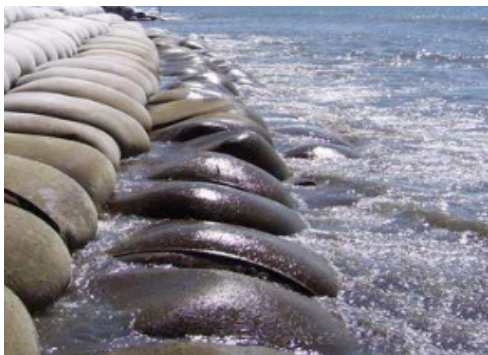
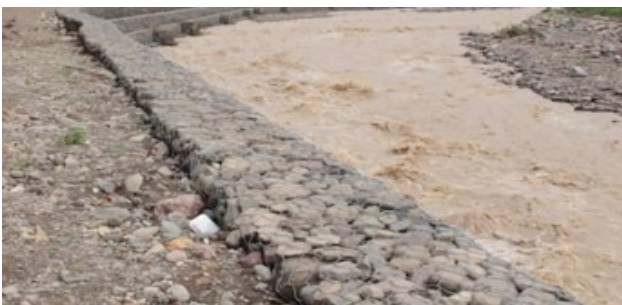
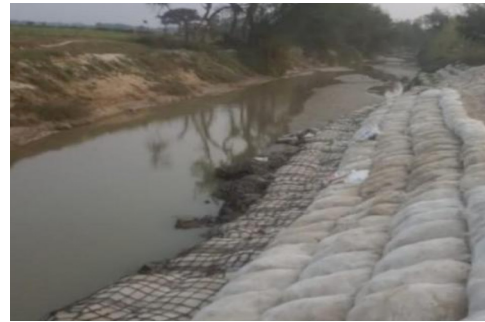
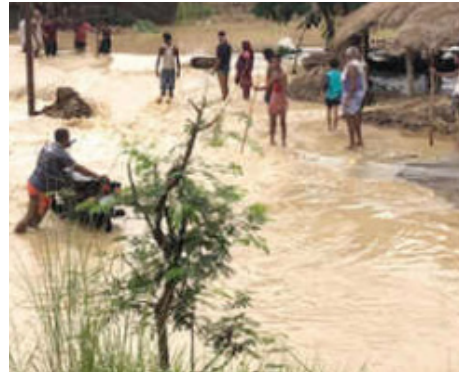
**Figure 1.** Flood and Anti-erosion works (a) after Singh (2010) [6], and (b) during lockdown in Bihar April 2020 [7], and (c) breach in Kamala Balan embankment near Jhunjharpur in July 2019 [8]

the embankments in position, large-scale anti-erosion works in the form of spur, and revetments are required before the flood season at vulnerable locations. Large chunk of the budget goes into the erosion control works. Bihar is the top most flood-prone state of the nation and has a series of continuous or discrete embankments facing erosion, overtopping, cutting or breaches at 63 places in 2004 [4]. Even in normal flood years, 2005 & 2006 reported embankments breach at 8 and 1 places, mostly in North Bihar, Kamala Balan occupied 7 and 1 places, respectively. Health and safety of the embankment remain under question, whatever may be justification (unprecedented rain, flood or cutting by villagers and anti-socials). Floods in Bihar result in significant human and financial losses annually. Prevention of erosion suggested was with boulder and sandy cement bags [5]. Amid recent anti-erosion practices using boulders and cement bags for flood issues in North Bihar [6] and works in progress during the period of COVID-19 [7] floods are playing their devastating role [8] (Figure 1).

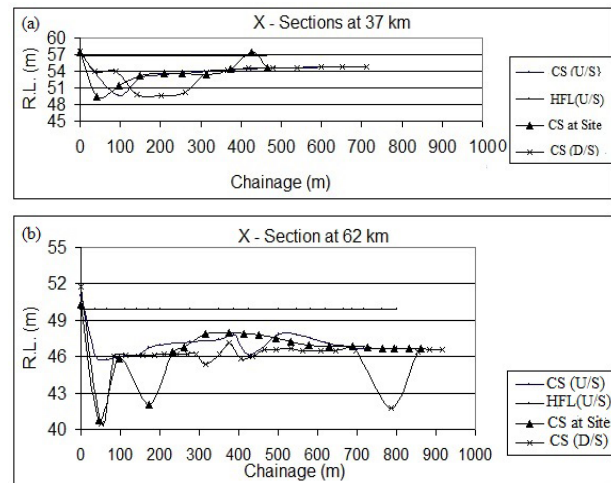
**Figure 6.** Cross-sections at (a) 37 km, 210m u/s and 260m d/s from km37, and (b) 62 km, 375m u/s and 525m d/s from km 62

Figure 6 (a & b) show river cross-sections at 37 km and 62 km, respectively. Average height of the embankment is 8 m and distance between east and west embankment is about 2 km. Table 1 shows the flood discharge and other hydraulic features computed based upon Slope-Area method using Manning's' equation (the governing equations, parameters and variables are defined in the concerned columns). The perimeter and cross-sectional area of the river at 62 km with water elevation of 49.8 m are 819 m and 2820 m<sup>2</sup>, respectively. An average slope of the riverbed is 0.317 m/km. The estimated flow velocity at 49.8 m (RL) of flow depth is 0.88 m/sec. The estimated flow velocity at 56.9 m (RL) of flow depth at Section 37 km is 0.93 m/sec. The normal scour depth calculated at section of km 37 and km 62 is 5.4 m and 6.4 m, respectively (Table 1). The radius of meandering and its curvature at 37 km is 500 m. It has-been developed due to shifting of the river courses towards the embankment by 300 m in 1987, 100 m in 1988 and 200 m in 1989. As a result of progressive shifting, it

was flowing only 30 m away in 1990 and 20 m away in 1991 to the embankment whereas, at the section of 62 km the river is braided and main flow runs parallel to the embankment striking and touching up to 3 km downstream.

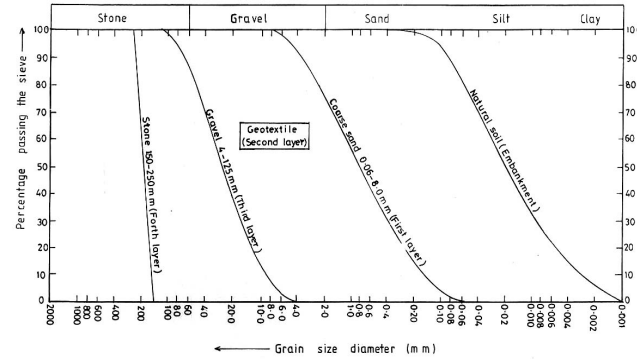
**Figure 8.** Shows silt, gravel and boulders size distribution curve, proposed for minimum thickness of riprap slope revetment

Based on the characteristics of both the study sections, the geo-textile aided revetment design as per grain size distribution of each layer (Figure 8) shows that a layer (A), of 10 cm thick coarse sand above natural soil, then a geo-textile layer (B) covered by 15 cm thick gravel layer (C), and a water front material (stone boulder) layer of at

least 20 cm thick satisfy stability, filter and uniformity criteria [26a]. Geo-textile reinforced revetment section (Figure 9) found suitable for the soil particle size and flood flow velocity analysed as 0.93 and 0.88 m/sec for the study sections at 37 and 62 km, respectively. However, as per site condition thickness of pitching layer may go up to 0.75 m for slope and 1.4 m for launching apron.
