Journal of Geological Research http://ojs.bilpublishing.com/index.php/jgr-a

ARTICLE Engineering Geological and Geotechnical Studies of Taprang Landslide, West-central Nepal: An Approach for Slope Stability Analysis

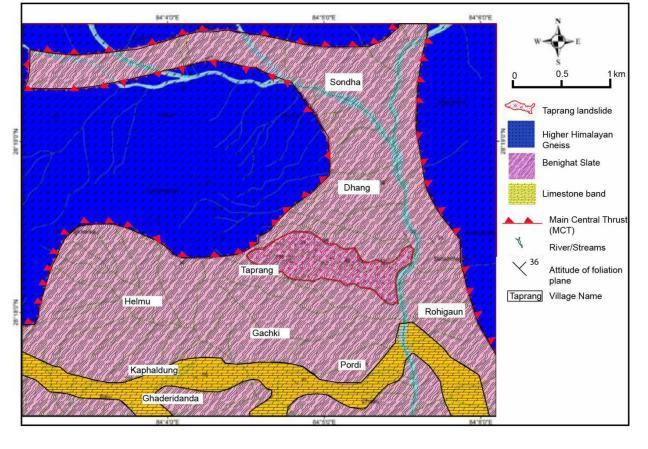
Figure 2. Generalized Geological Map of the Landslide Area (Modified from Regmi, 2017)^[38]

Geologically, the landslide area and its periphery covers parts of the Lesser Himalayan and the Higher Himalayan Zones of the Nepal Himalaya^[41]. The Lesser Himalayan Zone comprises variegated calcareous graphitic schist with grey to white quartzite, limestone and marble. The thickness of the individual beds of schist and quartzite with calcareous rocks such as limestone and marble range from 1mm to 50 cm and 10 cm to 1.5 m respectively. Similarly, the Higher Himalayan Zone comprises high grade metamorphic rocks such as schist, quartzite and gneiss. Similarly, detail geological study ^[38] also revealed that the landslide area falls in the Benighat slate and its equivalents of the Nawakot Complex of the Lesser Himalayan Zone in central Nepal established by ^[42]. This unit is separated from the Higher Himalayan zones by the Main Central Thrust (MCT) at upper part of the crown of Taprang landslide (Figure 2). Lithological, landslide area consists of highly weathered, fractured and sheared mica and garnet bearing schist, gneiss and quartzite in the crown to toe parts respectively.

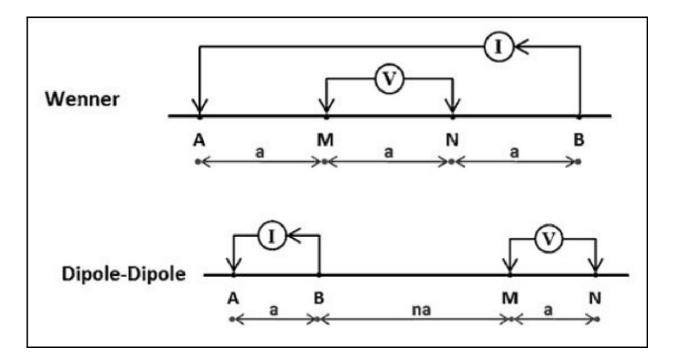
Figure 3. General electrodes configuration of ERT survey

The ERT measuring procedure consists of resistivity measurements along the pre-defined profiles, where uniformly placed stainless steel electrodes are used. The automated, programmed measurement is taken for all possible combination of electrodes, depending on the selected measured array^[43]. The increase in the spacing increases the depth range of research determined in this method for approximately one-fifth of the distance between the extreme electrodes. As a result of measurement, the apparent resistivity of rocks, representing the result of the entire heterogeneous, complex anisotropic layers, is determined in accordance with Ohm's law. The most commonly used measuring systems are the Wenner and dipole-dipole arrays due to good depth range and the best horizontal resolution, respectively^[44,45]. (Figure 3). The instruments used during ERT survey are Multi-function digital DC Electrical Resistivity (GD-10, Geomative), multiplex electrode converter (multi electrode switching equipment CS 60), multi core cables with each takes out at every 5 m and battery with 144 volt. The Wenner and Dipole-Diople arrays, which are sensitive to vertical structures and characterized by the maximum depth of penetration, was used. Data were acquired by Wenner and Dipole Dipole configurations using a 60-electrode cable 5 m apart. The data processing and interpretation was carried out by RES2D-INV software using a nonlinear optimization technique with a 2D inversion process. The least-squares inversion methods of inversion are used in RES2DINV program. The calculations also take into account the terrain layout including the topography in the data processing ^[46].

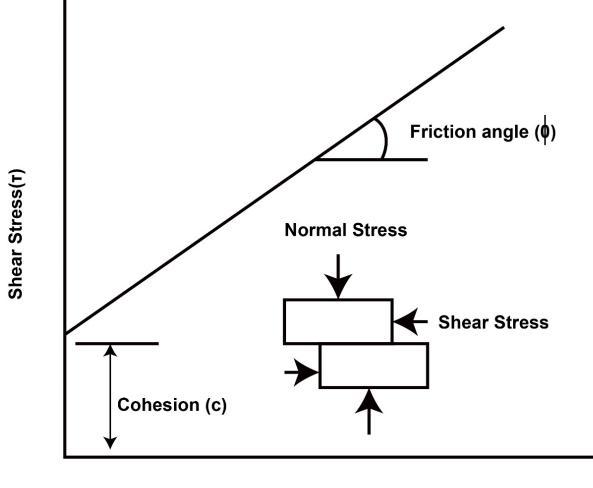
Figure 4. Relationship between Normal stress and Shear stress ^[47]

The obtained Normal stress (σ) and Shear stress (τ) parameters of the soil samples is plotted on the Normal stress & Shear stress to obtain the value of cohesive strength (c) and internal frictional angle (ϕ) of the soil samples (Figure 4).

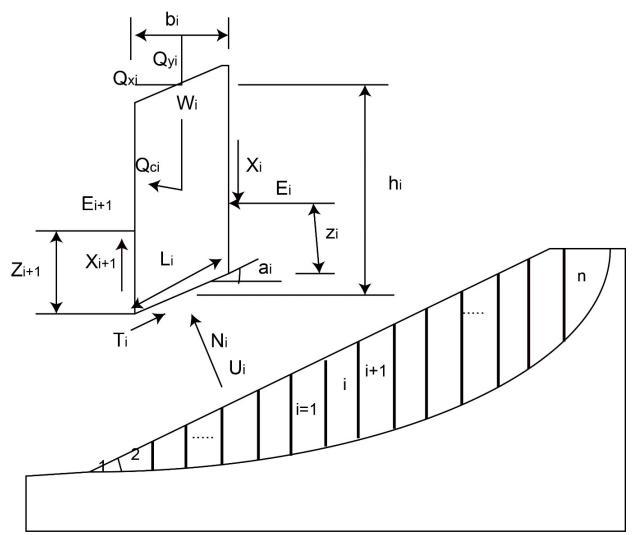
Figure 5. Method of interslice along the slope based on $LEM^{[48]}$

Due to complex nature of the Taprang landslide, it is impossible to conduct a single overall slope stability analysis. Therefore, kinematic analysis was used to establish the nature of rockslides in schist and quartzite near the main body part of the landslide, which may have played a key role in triggering the soil slide. The limit equilibrium Method (LEM) slope stability analyses of soil was performed using the commercial slope stability software Rocscience Slide 6.0. The analysis was performed by using two stability analysis method i.e. Bishop and Janbu method. In Limit equilibrium Method, colluvium deposits of slope between slip surface and upper layer of the ground is divided into n slices (Figure 5). Weight (Wi), the horizontal force such as earthquake (seismic load) (0), the horizontal and vertical load (Oxi.), the water pressure (*Ui*), the interslice forces (Ei, Xi, Ei+1, Xi+1), the normal force (Ni), and the sliding force (Ti) of the slip surface are the overall forces acted on the *i*th slice ^[48]. The factor of safety is calculated as:

$\mathbf{F}_i = \frac{N_i \tan \varphi_i + c_i b_i \sec a_i}{T_i}$

Where, *ci* is the shear strength parameters of the slip surface and *bi* the width of the slice.

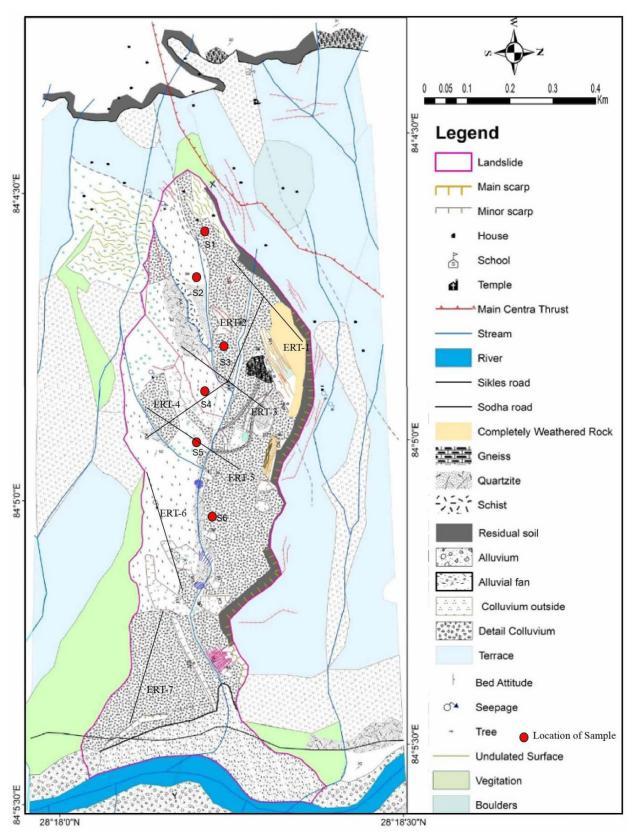
Figure 6. Detail Engineering Geological map of the Taprang landslide and its periphery

A detailed engineering geological map of the Taprang landslide was prepared covering its periphery (Figure 6). The landslide comprises mainly of thick colluvium deposit and residual soil. The studied Taprang landslide is a complex type of slide consisting of the combination of several types of slides such as slide, fall and flow. Few other small scale slides are also present with in this landslide. The crown is mainly extended towards left flank of the landslide where mainly residual soil is present. The residual soil and the colluvium are the main lithology at the crown area. A large scrap is present at this places. Damaged school building, and small temple with cracked walls are present in the crown area (Figure 7 A). The rotational movement of the crown part is indicated by the tilted trees (Figure 7 B). The slope angle of the crown to main body part is about 32°. The geomorphology of the landslide from top crown part to toe part is quite distinctive due to variation of slope, deposited materials, rock exposures, rock cliff, and degree of weathering and nature of slide. Several cracks are also present at the crown part., which are aligned parallel to the main scarp. Numerous small soil slides, patches, undulating surface was observed. Water can easily flow through such cracks, thus facilitating the expansion of the landslide as well as weathering of rocks. The length of the cracks ranges from 1-3 m and depth up to 1 m by visual inspection.

The main body part of the landslide is covered by thick colluvium which consists of pebbles, cobbles and boulders of schists, and quartzite. The size ranges from 1-5 mm in diameter. Several tensional cracks and vertical cracks are also observed throughout the middle part of the landslide area. The length of the cracks ranges from 1-5 m and depth up to 2 m by visual inspection. Bedrock of schist are visible in the outcrop in some places which is highly

weathered, fractured and jointed and attached to the colluvial mass. The slope angle of the middle part of the slide is about 10°. A scarp of the landslide with bedrock is observed just end of the middle part of the landslide where mainly highly weathered schist and quartzite is present (Figure 7C). Some rock fall debris is also present in this area (Figure 7D). The slope is about 40° towards toe area. Several seepage zones are observed within the upper and middle part of the area which may be due to the percolation of water from hill slope. The land use of the main part of the slide is grassland and forest in right flank of the landslide. At the left flank, paddy and cultivated land is present and soil is loosen by the infiltration of water.

At the toe of the landslide, mainly colluvium deposits is present which is carried by the small drainages from crown part and active soil slides along the left flank of the landslide. The width of the toe of landslide is more than 100m from earlier failures consisting predominantly of coarse granular soil with some boulders and cobbles (Figure 7E). The slope angle is about 5-10°. On the other hand, weathered and fractured graphitic schist is exposed at the other side of the landslide.

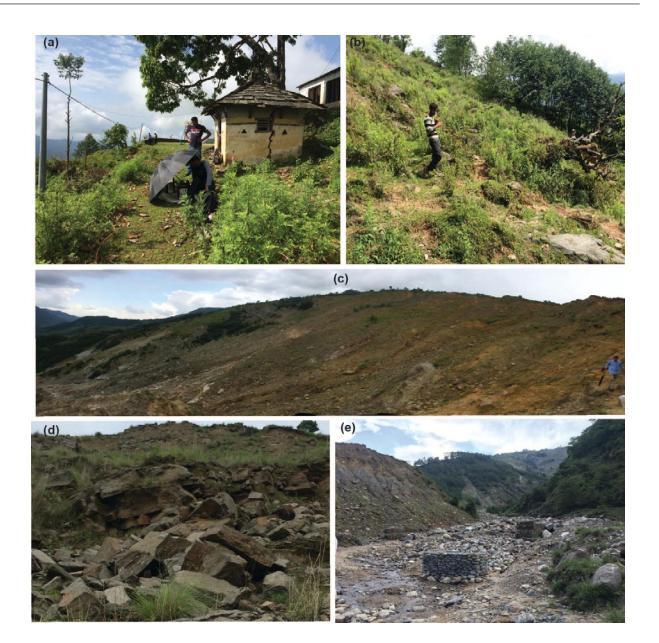
Figure 7. Several field features of the Taprang landslide.
(a) Damage wall of temple located at Crown part; (b) Tilted trees showing the active rotational movement at crown;
(c) Large soil and rock scrap at middle main body part d) highly weathered fractured bedrock with rock debris at middle part; (e) Overall landslide featured observed from the toe part

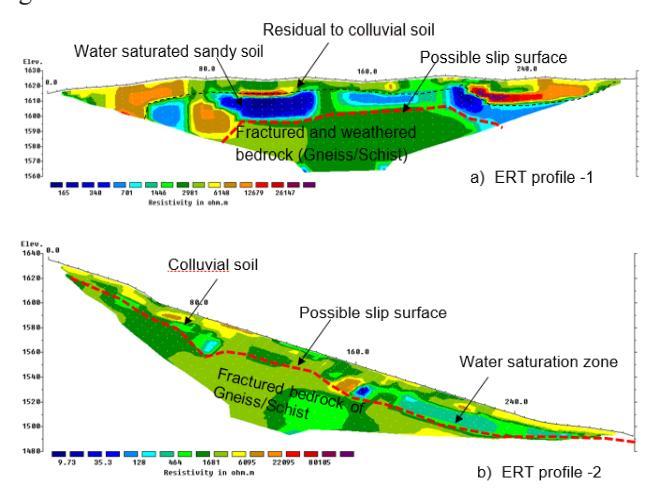
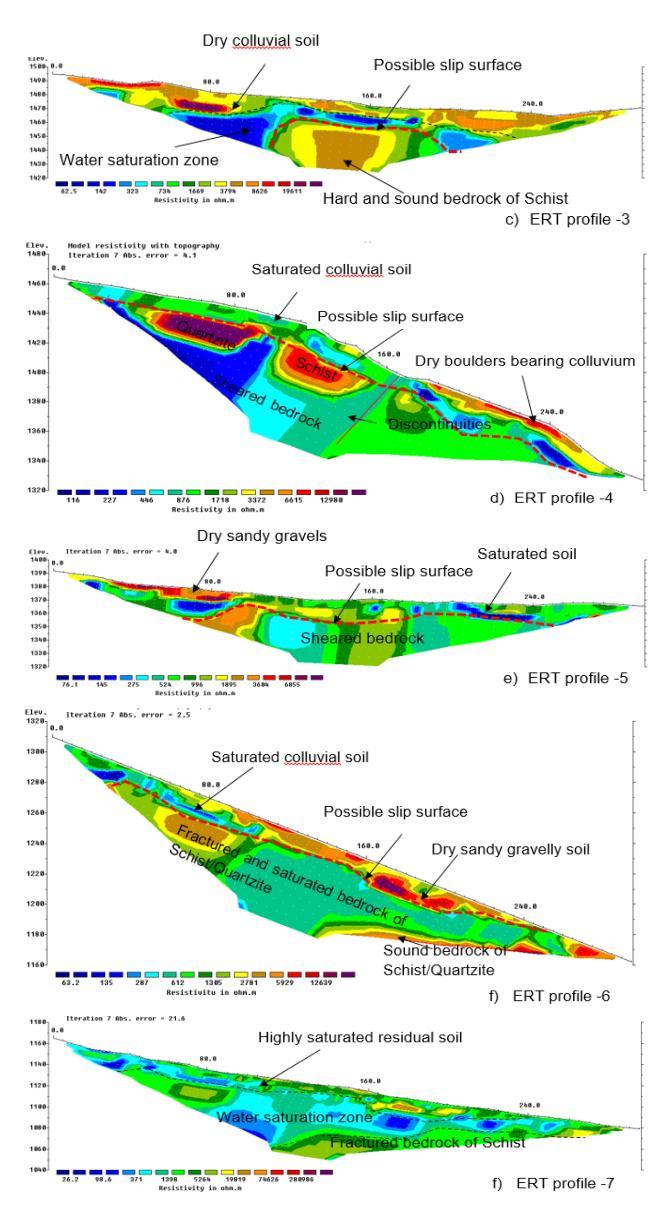
Figure 8. Electrical resistivity tomography results: a) Across the landslide at crown; b) Along the landslide movement at crown; c) Across the landslide at body part; d) Along the landslide at body part; e) Along the landslide at body part; f) Along the landslide at left flank of the toe part g) Along the left flank of landslide at toe part

In the crown part, ERT profile 1 and 2 (across and along) show the distinct three layers from surface to bottom (Figures 8a, 8b). Upper Layer of the crown part consists of dry to partly saturated colluvium which have the resistivity value ranges from 1000 to 6000 Ω m. The depth of this colluvium is about 10 m from the surface. This soil probably originated from slide mass derived from old landslide materials. A water saturated zone with clay and sandy layer is present from depth 10-25 m from the surface of resistivity value ranges from 100-1000 Ω m. This layer marks the boundary between overburden and

bedrock. Hence slip surface is considered just below the saturation zone at depth 20-25 m from the surface. The bottom layer consists of highly fractured and weathered bedrock of gneiss which have resistivity value ranges from about 1500-6000 Qm Profiles 3, 4 and 5 were carried out in the main body part and consists of dry colluvium with resistivity value ranges from 2000-8000 Ω m. The depth of this colluvial layer varies from 10-20 m. A water saturated zone is present below 10-20 m from surface with resistivity value ranges from 50-300 Qm. This may represent the water table zone. This layer extends below depth up to 30 m and it shrinked at center and again expands towards right flank which is seen in the tomogram. At 20-30 m below surface, there is a boundary between top saturated zone and bedrock which represent the slip surface (profile 3, Figure 8c). Similarly, profile 4 shows that thick covered saturated to dry colluvial soil is present up to depth 10 m from surface. The resistivity value of this layer ranges from 700-6000 Ω m. At central part, there is a presence of boulder like rock patches which may represent bedrock of schist and quartzite which is also visualized by field observation. The resistivity value in this zone ranges from 3000-12000 Ω m. The depth of this layer exposed up to 20 m (i.e. 10-25 m) below surface. There is presence of structural discontinuities i.e. sheared zone in different places of this tomogram which is indicated by the presence of sheared bedrock of low resistivity value (100-500 Ω m) (Figure 8d). Similarly, upslope of the main body part consists of dry gravels and saturated soil as upper layer as shown in profile 5 (Figure 8e) with resistivity value 200-3000 Ω m. The depth of this colluvium extends up to 10 m from the surface. A water saturated zone is present below depth 10 m and found up to 20 m with resistivity value ranges from 70-200 Ω m. Below the water saturated zone, all three profiles show the sound to fractured and sheared bedrock of schist and quartzite with resistivity value ranges from 500-8000 Ω m (Figure 8e). The resistivity contrast between water saturated zone and below hard bedrock is considered as slip surface in the main body part found at depth 10-20 m from the surface.

In the left flank of the toe area (profile 6 and 7), a highly saturated colluvium and residual soil present at depth 5-15 m from the surface with resistivity value 20-5000 Ω m (Figure 8f, 8g). The distinct second layer consists of very low resistive, highly saturated, fractured porous zone where water is flowing throughout the layer and found below depth 10-50 m from the surface. The resistivity value of this layer ranges from 100-1000 Ω m. This layer marks the boundary of bedrock and colluvium. Below this layer, highly fractured, weathered bedrock of schist is present which has resistivity value ranges from 1000-8000 Ω m.

Based on the above result of ERT survey, it is concluded that the upper layer shows the dry sandy to gravelly soil. Groundwater table is undulating and identified at average 12 m depth from the surface. The slip surface is varied from depth 25 to 20 to 10 m from the surface in different locations from crown to main body part of the landslide. This geometry indicate the rotational and curved. The geometry and depth of the slip surface are used for slope stability analysis.

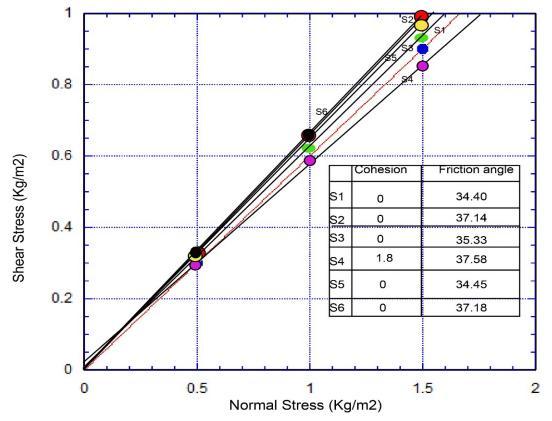
Figure 9. Calculation of shear strength parameters from direct shear test

From the results of direct shear test, the internal friction angle and cohesion of soil samples were determined. The soil samples collected from Taprang landslide has cohesion values almost all is zero because the absence of cementing materials which helps to combine soil particles tightly. The internal friction angle ranges from 34°-37°. These values indicate that the colluvial soil strength is quite low in the Taprang Landslide. The friction angle of granular soil is not a material constant, but depends on relative density and pressure level. Also friction angle of sandy soil decreases with increasing confining pressure, thus implying a circular soil failure envelope. Sand typically has negligible shear strength at zero confining stress and is generally modeled with a cohesion value of zero. The plotted graphs between Normal and Shear stress are shown in Figure 9.

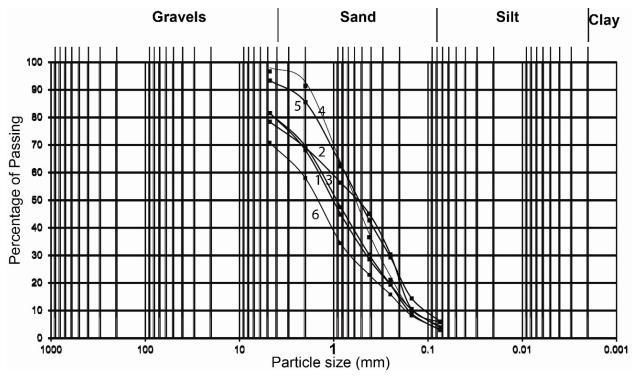
Figure 10. Grain size distribution curves of different soil samples

The grain size analysis shows that four samples are falls in the well-graded sand (SW) and two samples are classified as poorly graded sand (SP-GP) based on Unified Soil Classification System (USCS). The grain-size distribution curves of the soils are shown in Figure 10 and summarized in Table 1.

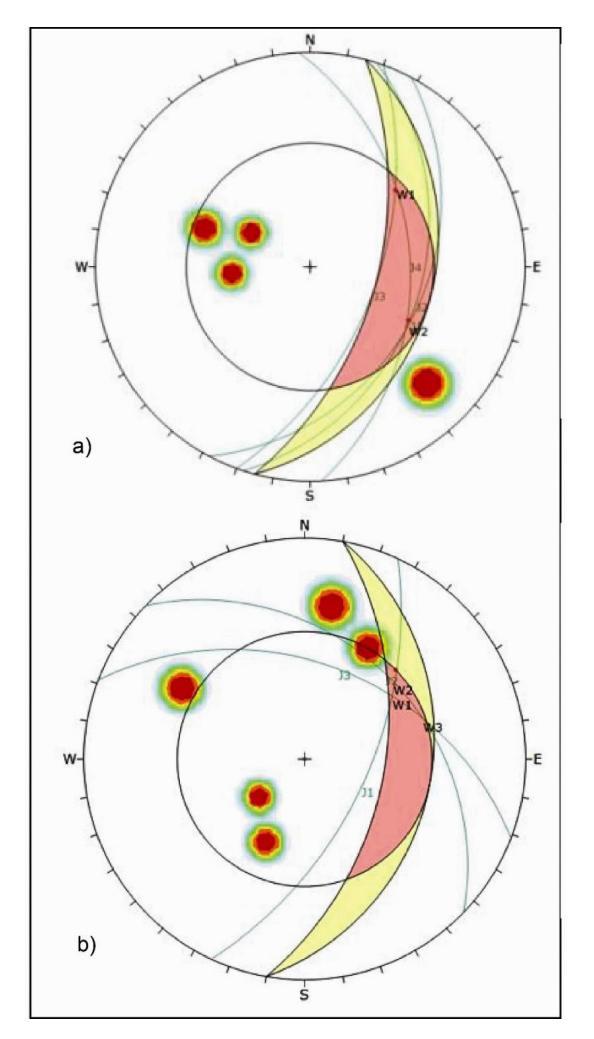
Field measurements show that a prominent discontinuity set in quartzite/ schist outcrops at the main body part of the landslide is oriented as $40^{\circ}/85^{\circ}$, $55^{\circ}/110^{\circ}$, $35^{\circ}/120^{\circ}$ and $75^{\circ}/315^{\circ}$ (dip/dip direction) in Figure 11a whereas the ground slope is oriented $55^{\circ}/105^{\circ}$, Similarly other discontinuities are $45^{\circ}/25^{\circ}$, $70^{\circ}/190^{\circ}$, $65^{\circ}/120^{\circ}$, $30^{\circ}/50^{\circ}$ and $60^{\circ}/210^{\circ}$ (dip/dip direction) whereas the ground slope is $50^{\circ}/100^{\circ}$ in Figure 11b. This indicates the slope is nearly parallel to the predominant discontinuities in that area as well as wedge are formed. Kinematic analysis of the discontinuous quartzite and schist using method proposed by ^[50] and the estimated rock friction angle suggests the slope is susceptible to rock sliding along the slope parallel discontinuities, as well as to wedge failures.

The analysis is actually the relationship of attitude of the natural hill slope with the attitude of discontinuities (joints and bedding planes). For natural hill slope, slope aspect and slope angle are taken into account whereas for discontinuities dip direction and dip angle are considered. The friction of the rock mass is also the area of interest in this analysis. The analysis is performed with aid of stereographic projection of the planes and lines of intersection of the planes^{[50].}

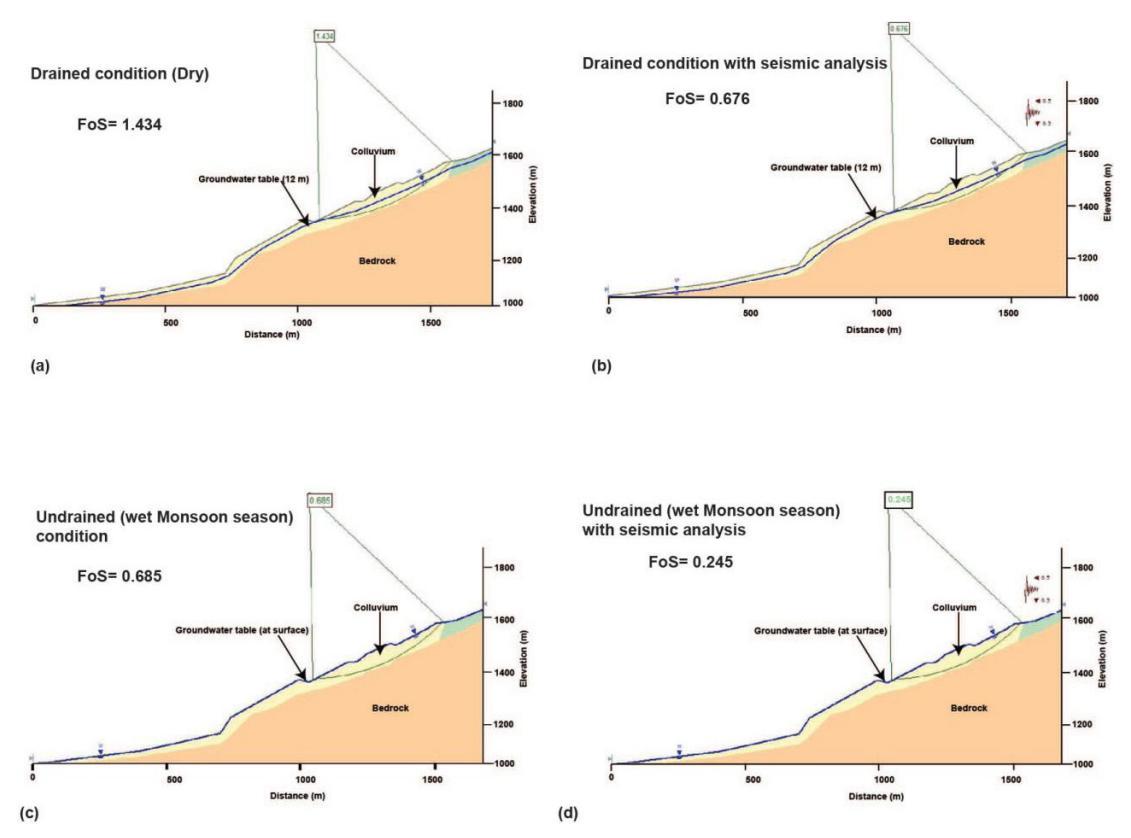
Figure 12. Results of limit equilibrium slope stability analysis of the Taprang landslide; (a) drained conditions (dry); (b) drained dry condition with seismic load; (c) Undrained (wet monsoon season) and (d) Undrained (wet monsoon season) with seismic load using Bishop method

Stability analysis of the main colluvium slope at Taprang landslide was performed using the parameters in Table 2. For the dry season condition, the groundwater table was specified at the above the saturated soil and bedrock and considered at 12 m from the surface (ERT data) and except at the locations of toe of the slope where it was allowed to rise to the ground surface. The soil-bedrock contact found at depth 25 m. The calculated factor of safety for drained (dry) and drained with seismic coefficient (0.5-horizontal and 0.3-vertical) show the 1.4 and 0.67 and 1.3 and 0.63 from both Bishop and Janbu methods ranges from respectively. Hence, differences among the Janbu and Bishop methods were negligible for each case (Figure 12 and 13). Based on the result of slope stability, slope is stable under drained condition but unstable in drained with seismic load condition (Table 3).

Similarly, the results for the undrained condition (wet), where groundwater table supposed to be on the surface and undrained with seismic analysis show the factor of safety are 0.68 and 0.24 (Bishop method, Figure 12) and 0.64 and 0.34 (Janbu Method, Figure 13) respectively. This indicates the landslide mass is least stable in wet undrained condition and unstable in undrained with seismic load in both cases respectively (Table 3). This variation of factor of safety under various loading condition shows that the slope which was once stable could result in failure with impose of external load such as groundwater rise and seismic activities such as earthquake.

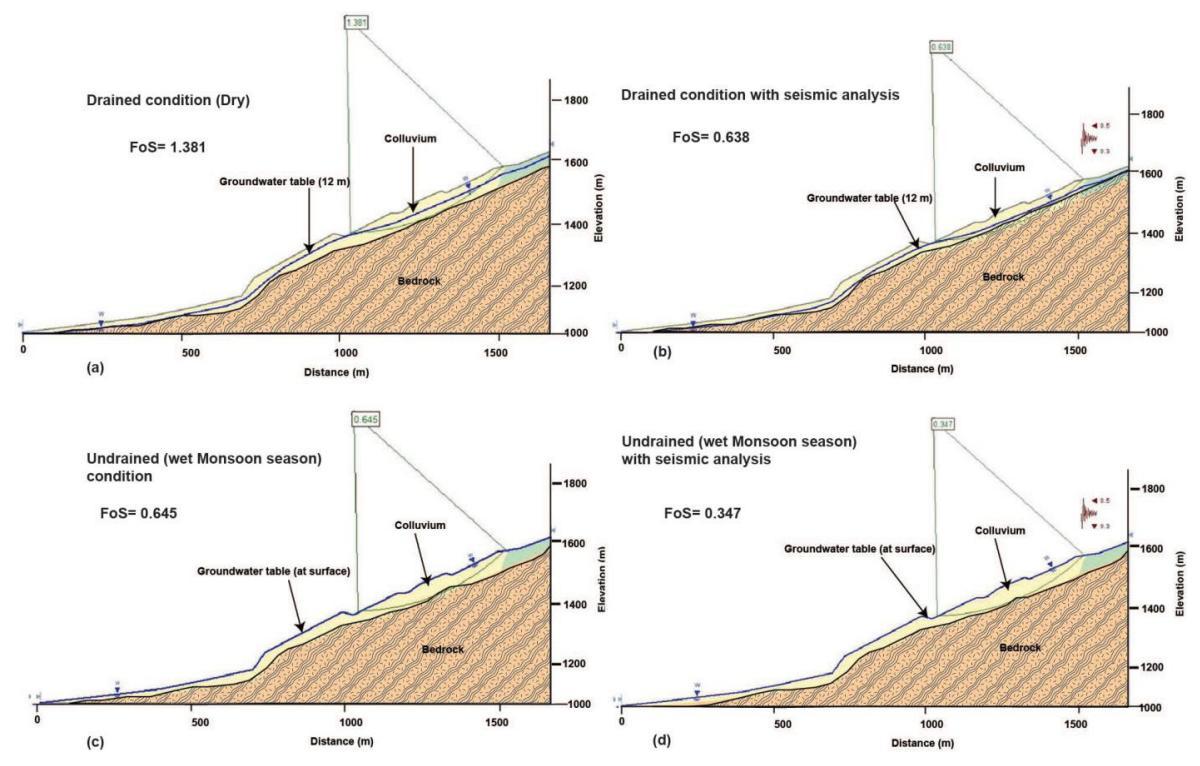
Figure 13. Results of limit equilibrium slope stability analysis of the Taprang landslide; (a) drained conditions (dry); (b) drained dry condition with seismic load; (c) Undrained (wet monsoon season) and (d) Undrained (wet monsoon season) with seismic load using Janbu method
